Displacement & Destruction: Analysis of Idlib, Syria 2017–2020

4 March 2020

Areas of Interest

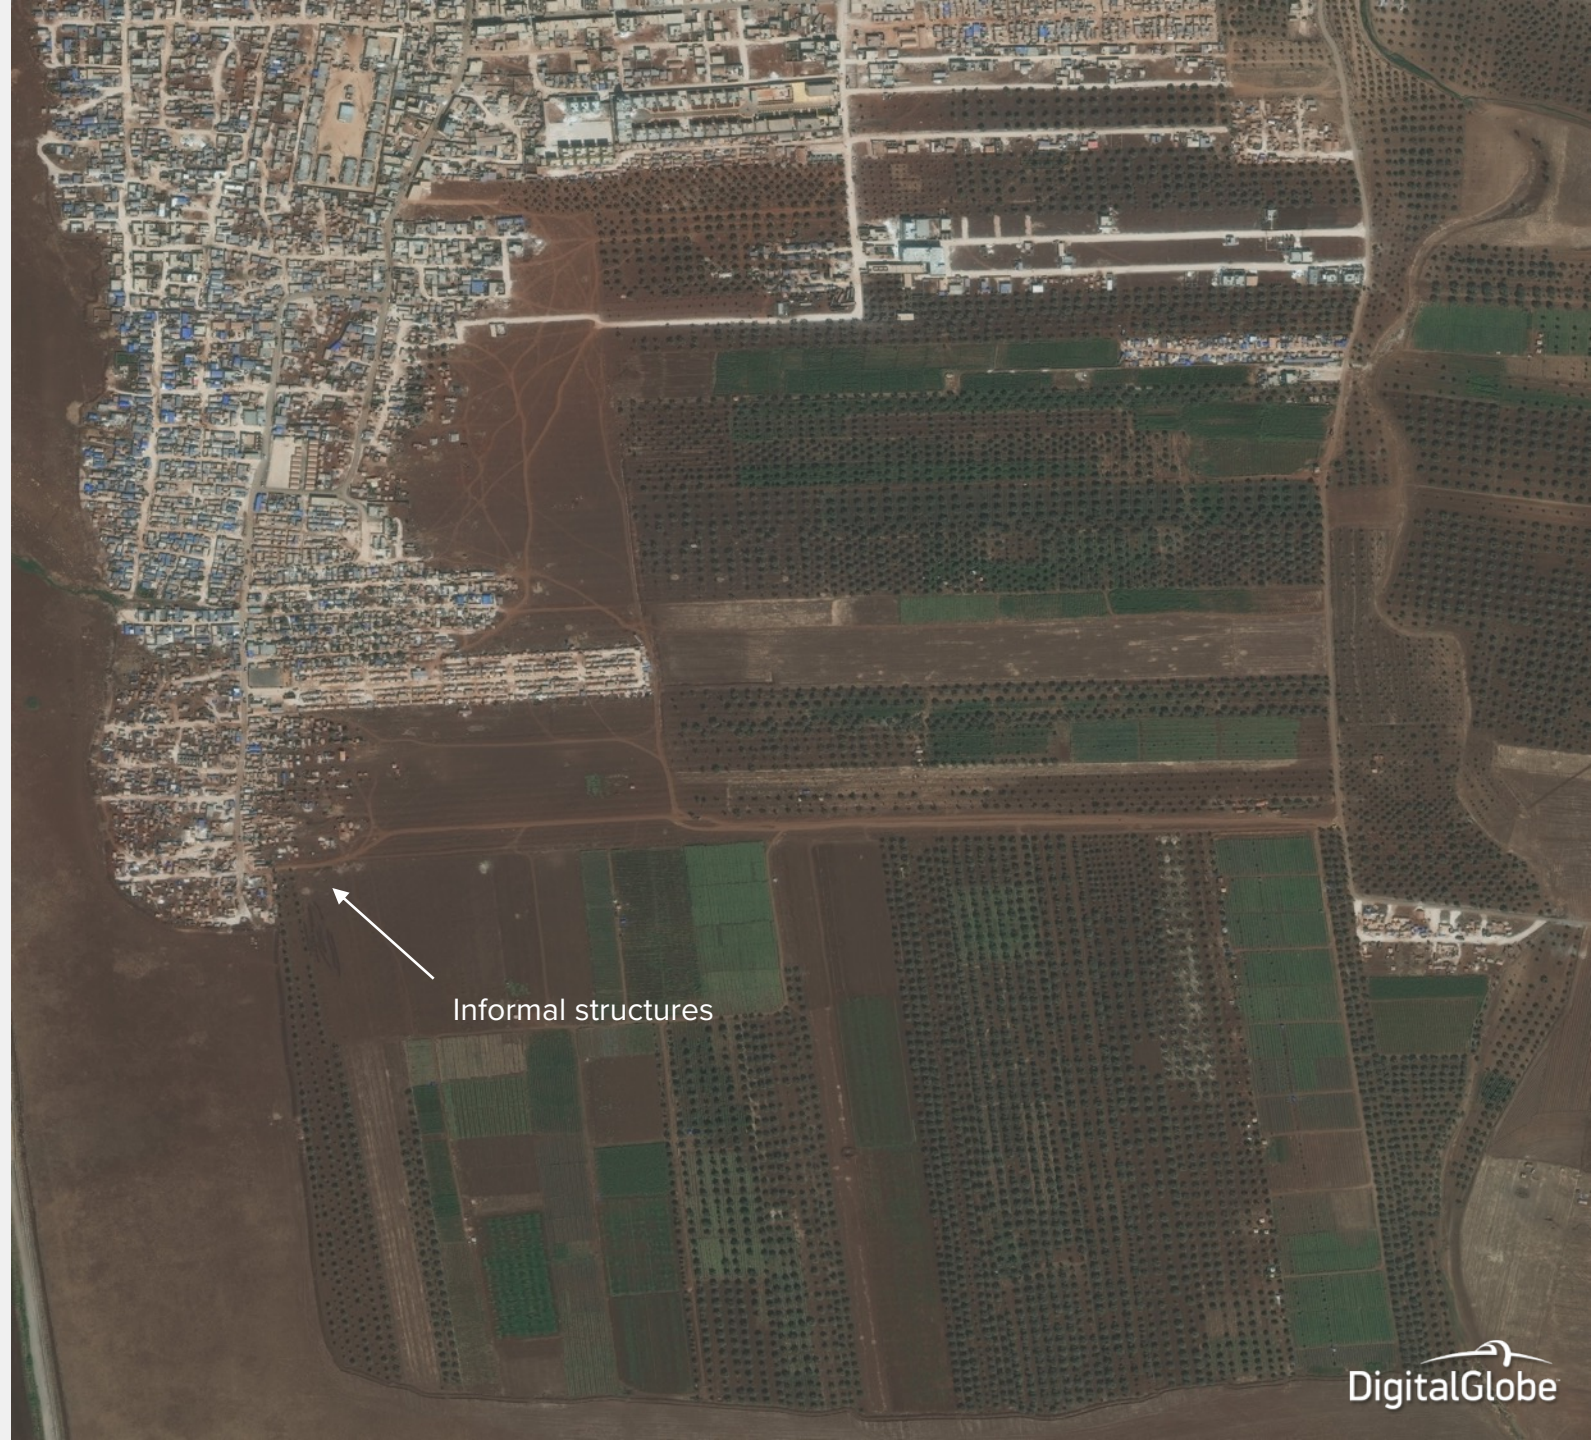
Informal structures

In September 2017, the IDP camp established to date was primarily concentrated in the NW of the image and was in close proximity to agricultural fields to the east. The structures appear heterogeneous in size, coloring, and material. Large parts of the camp appear to be formalized and organized, and there are road connections visible in close proximity to the densely settled areas.

Around the edges of the camp, particularly in the SW, there is a concentration of unorganized, smaller, informal structures. This cluster of structures is consistent with a self-settled and spontaneous camp. Singular informal structures are also visible in the agricultural fields around the camp.

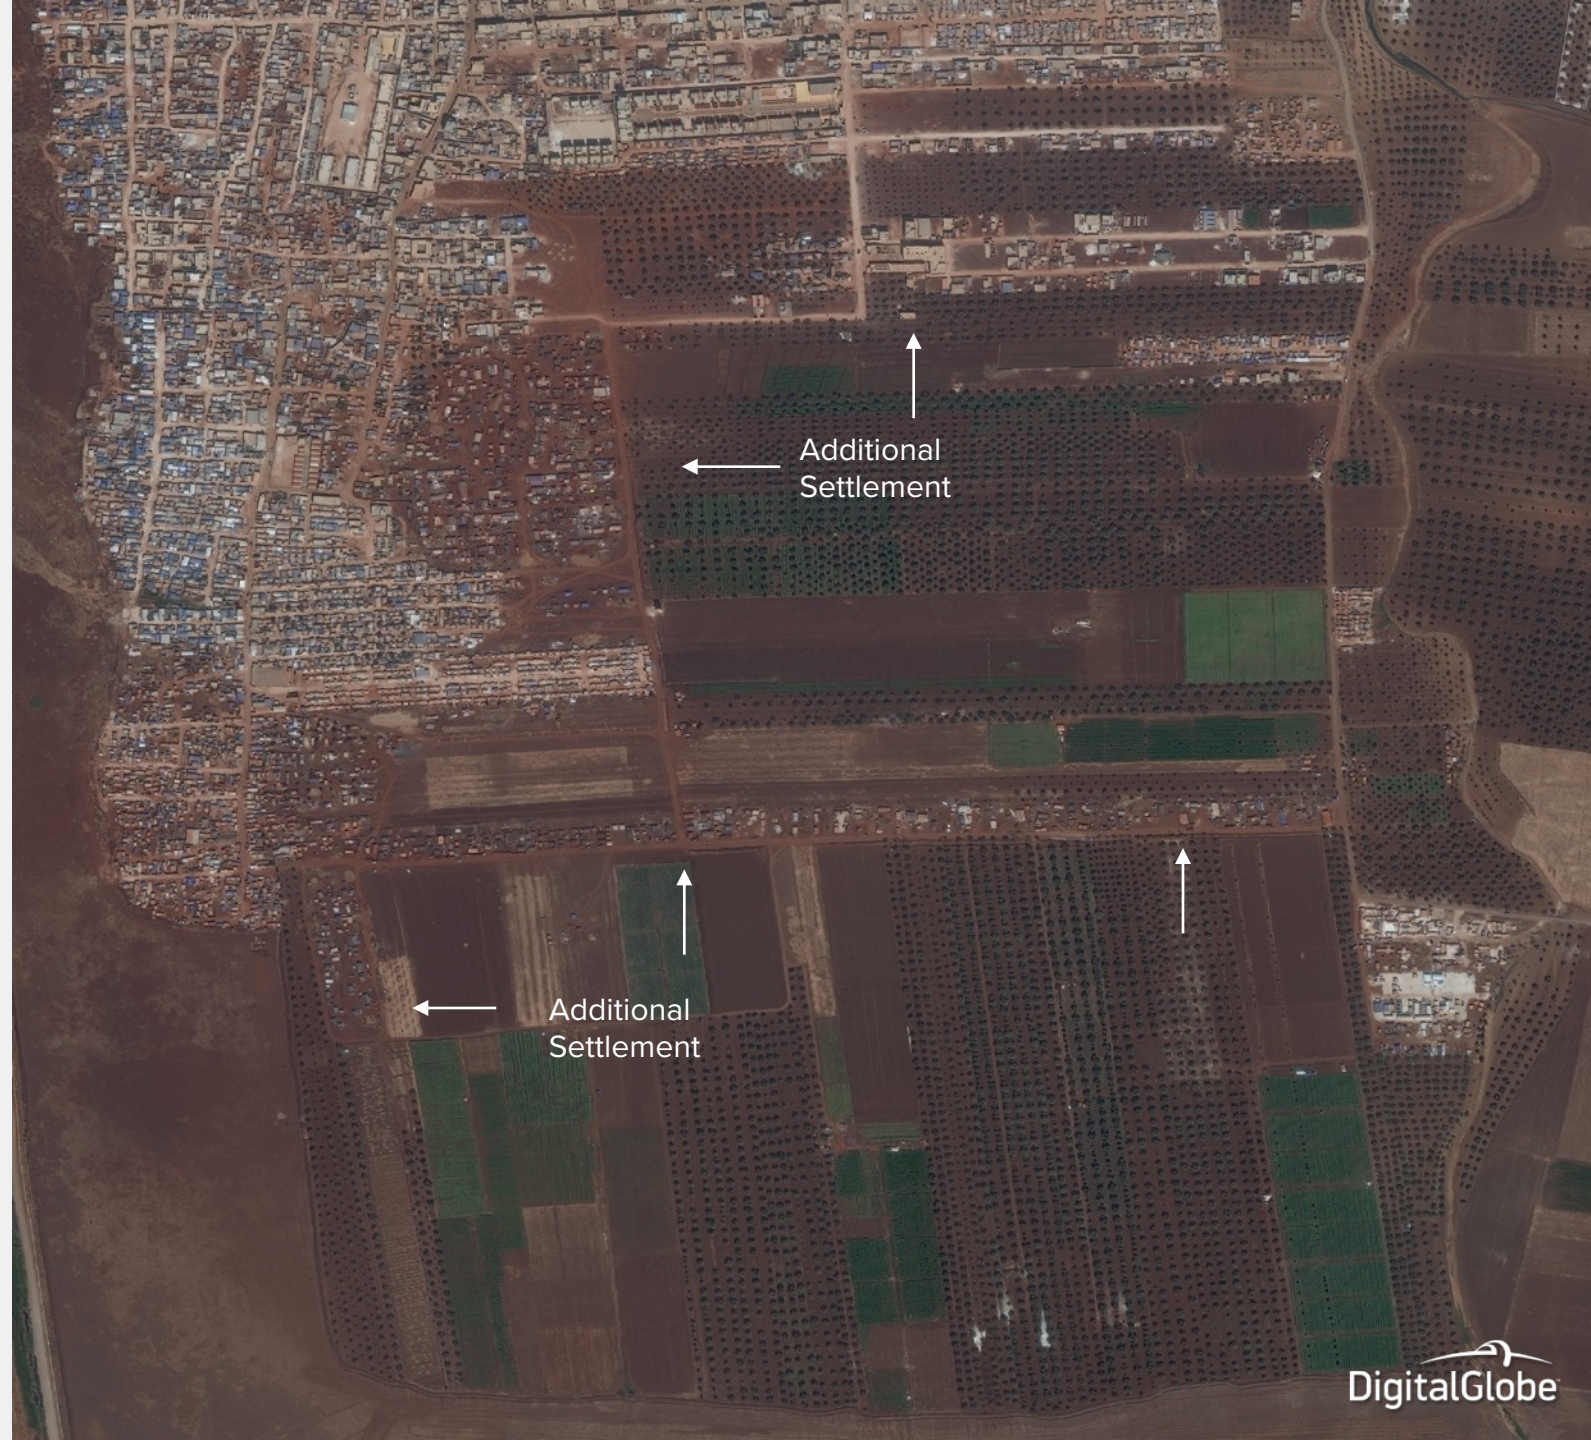
In September 2018, additional self-settled populations lined the edges of the established camp in large numbers. These newly added structures resemble the informal structures previously seen bordering the southern parts of the camp in September 2017. The added temporary structures between 2017 and 2018 appear smaller compared to the older, more well-established parts of the camp. There are no established road networks, and there is little apparent organization of visible structures; this may be consistent with recent arrivals.

The road networks visible in both September 2017 and 2018 are increasingly bordered by development in 2018.

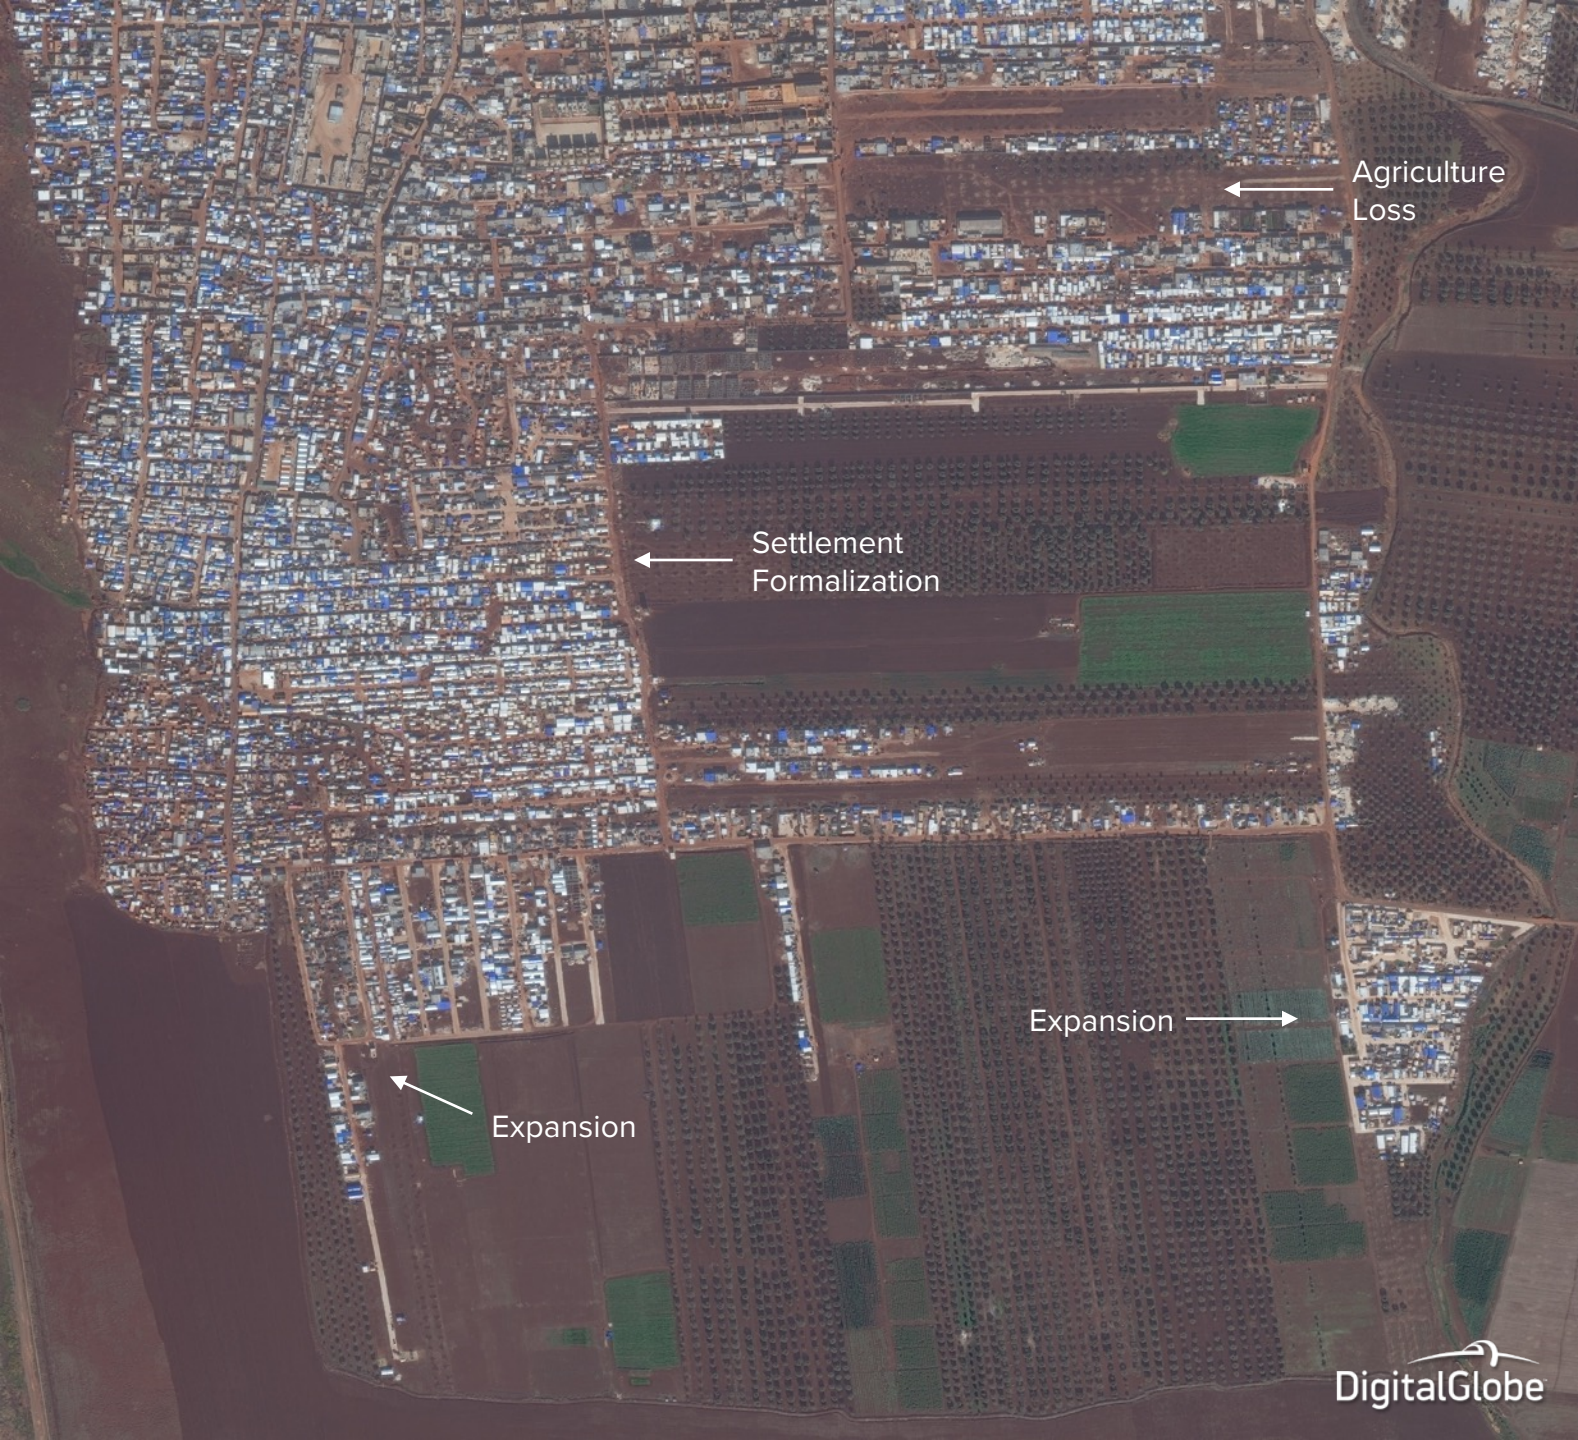
Between 2018 and 2019, the same areas that expanded with informal settlement the prior year became more formalized. The temporary structures visible in 2018 appear to have been replaced by larger, more permanent structures with sturdy roofing by 2019. The expansion continues to take over former agricultural fields; the removal of orchard trees may indicate further planned expansion.

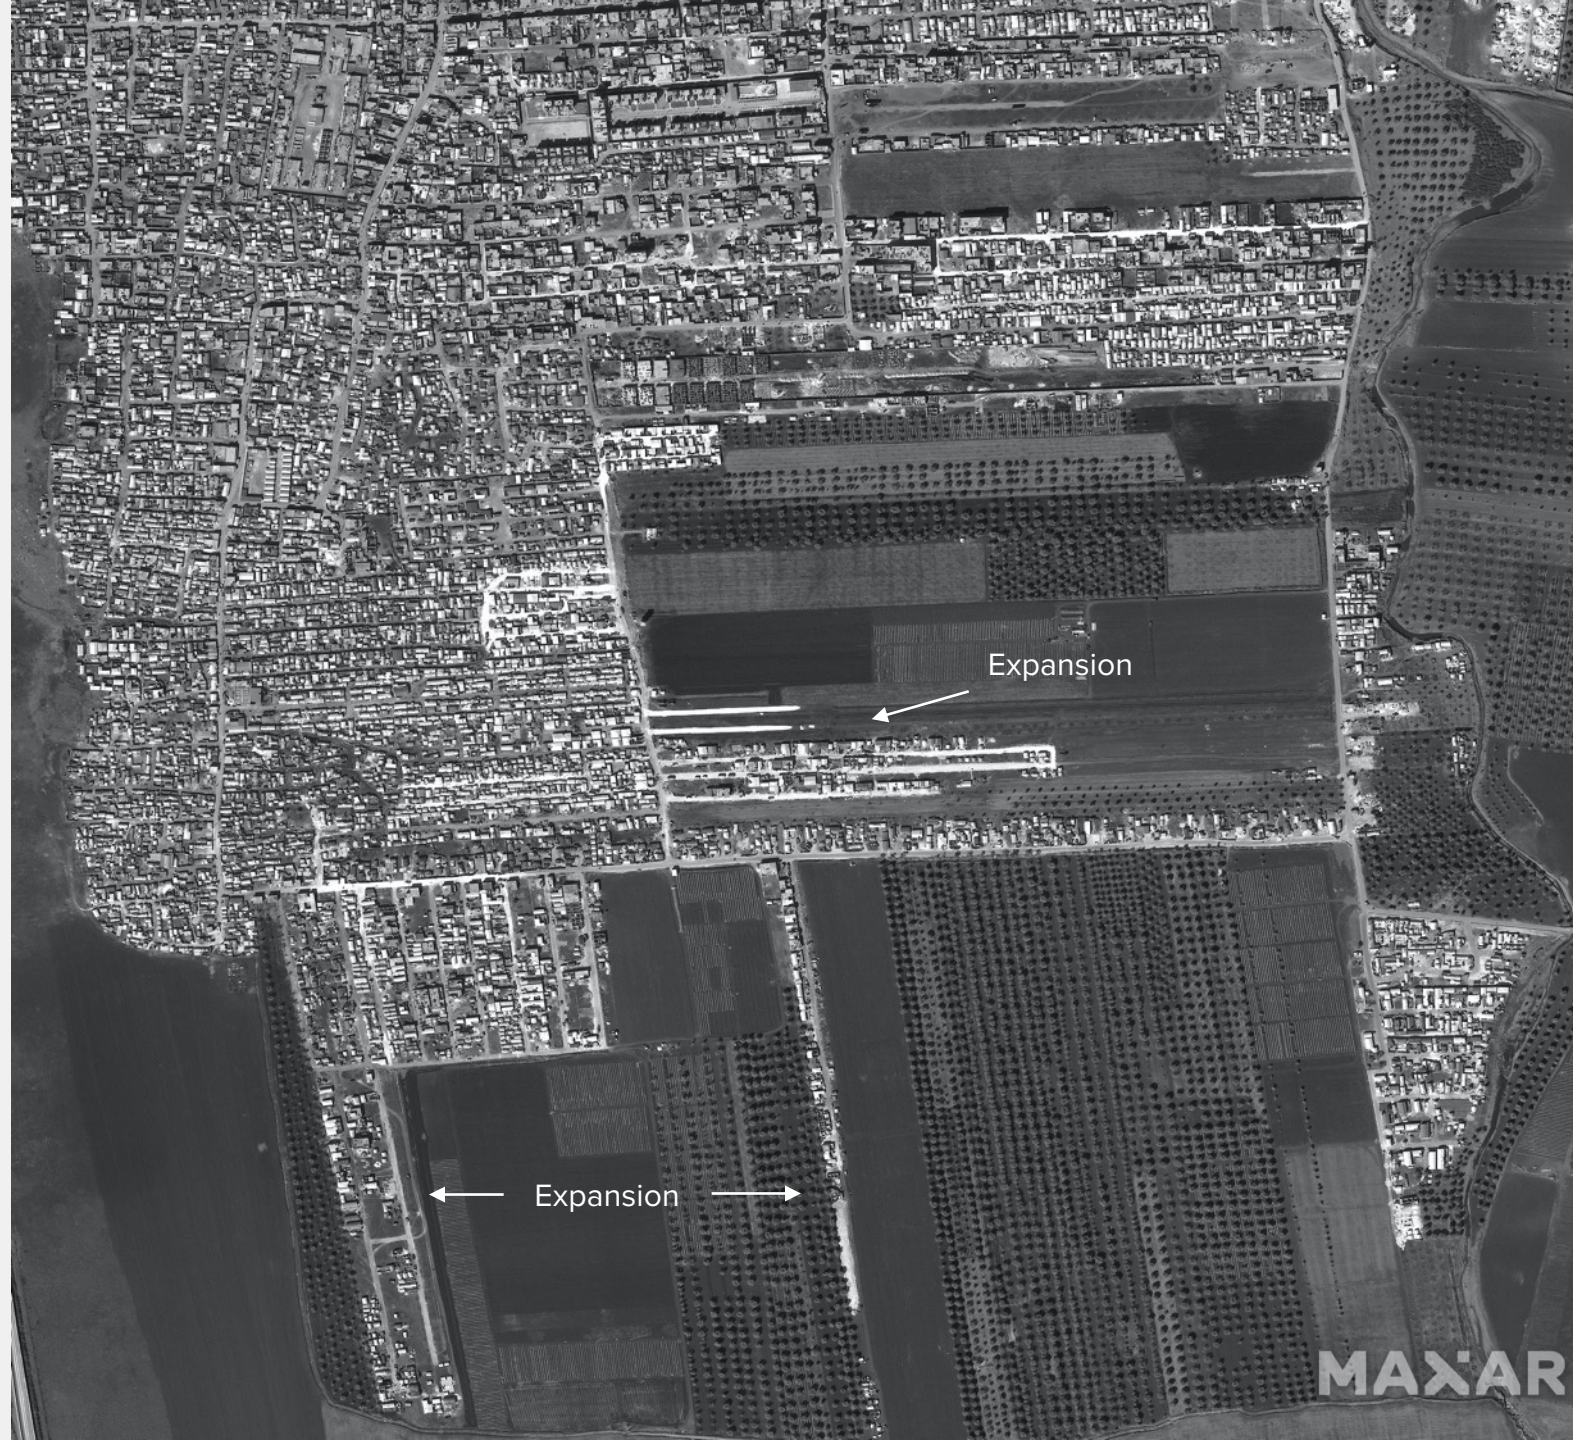
Between December 2019 and February 2020, additional construction is visible. New building foundations have been laid, and several structures that were undergoing construction in December 2019 have roofs by February 2020.

There are also several structures without roofing in December 2019 that are not completed by February 2020.

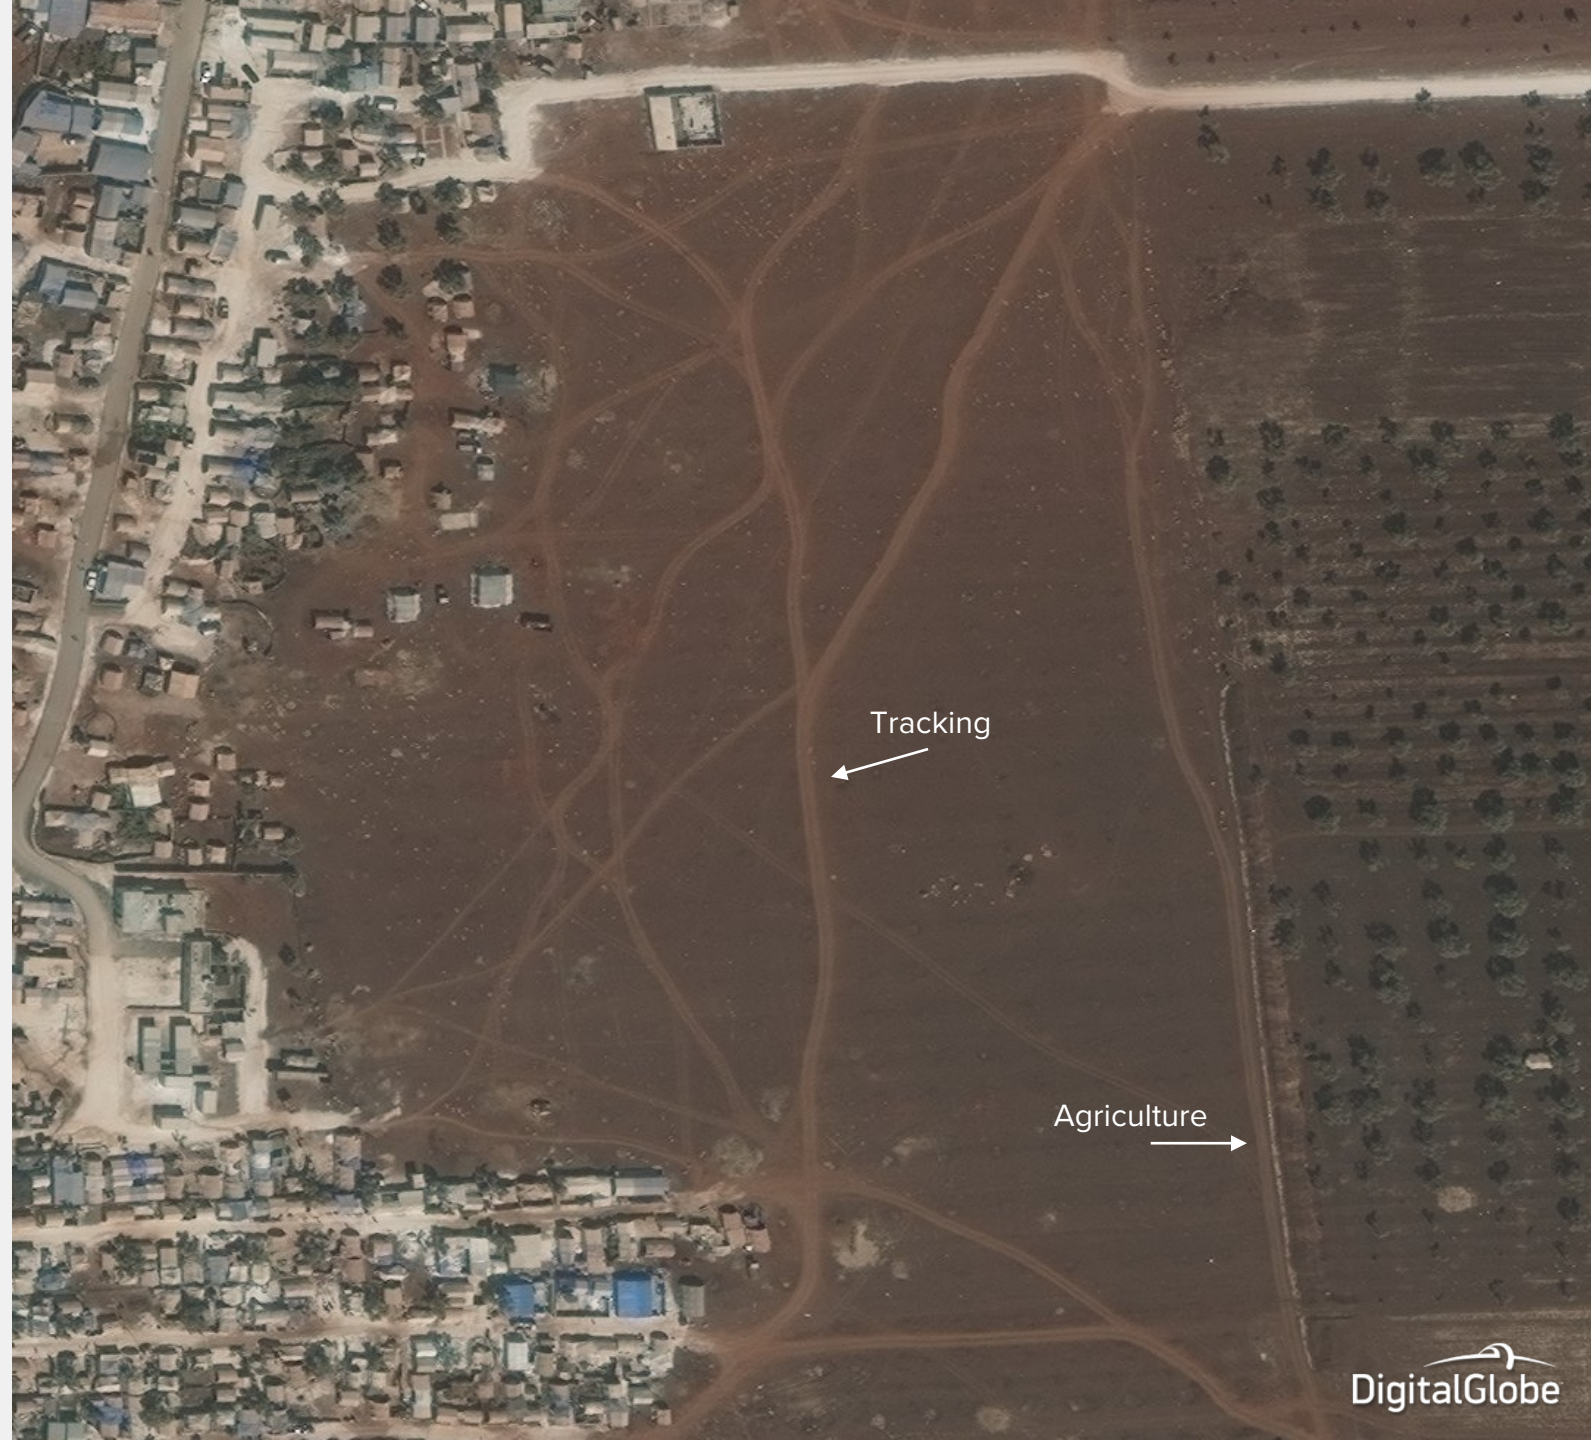
Fig 2.a. IDP Camp, Idlib Governorate
27 September 2017

The structures throughout displacement camp A are heterogeneous in size, coloring, and material. Agricultural fields border large parts of the camp, and here there is a clearing in between. Track marks are visible, but the space is not occupied by structures.

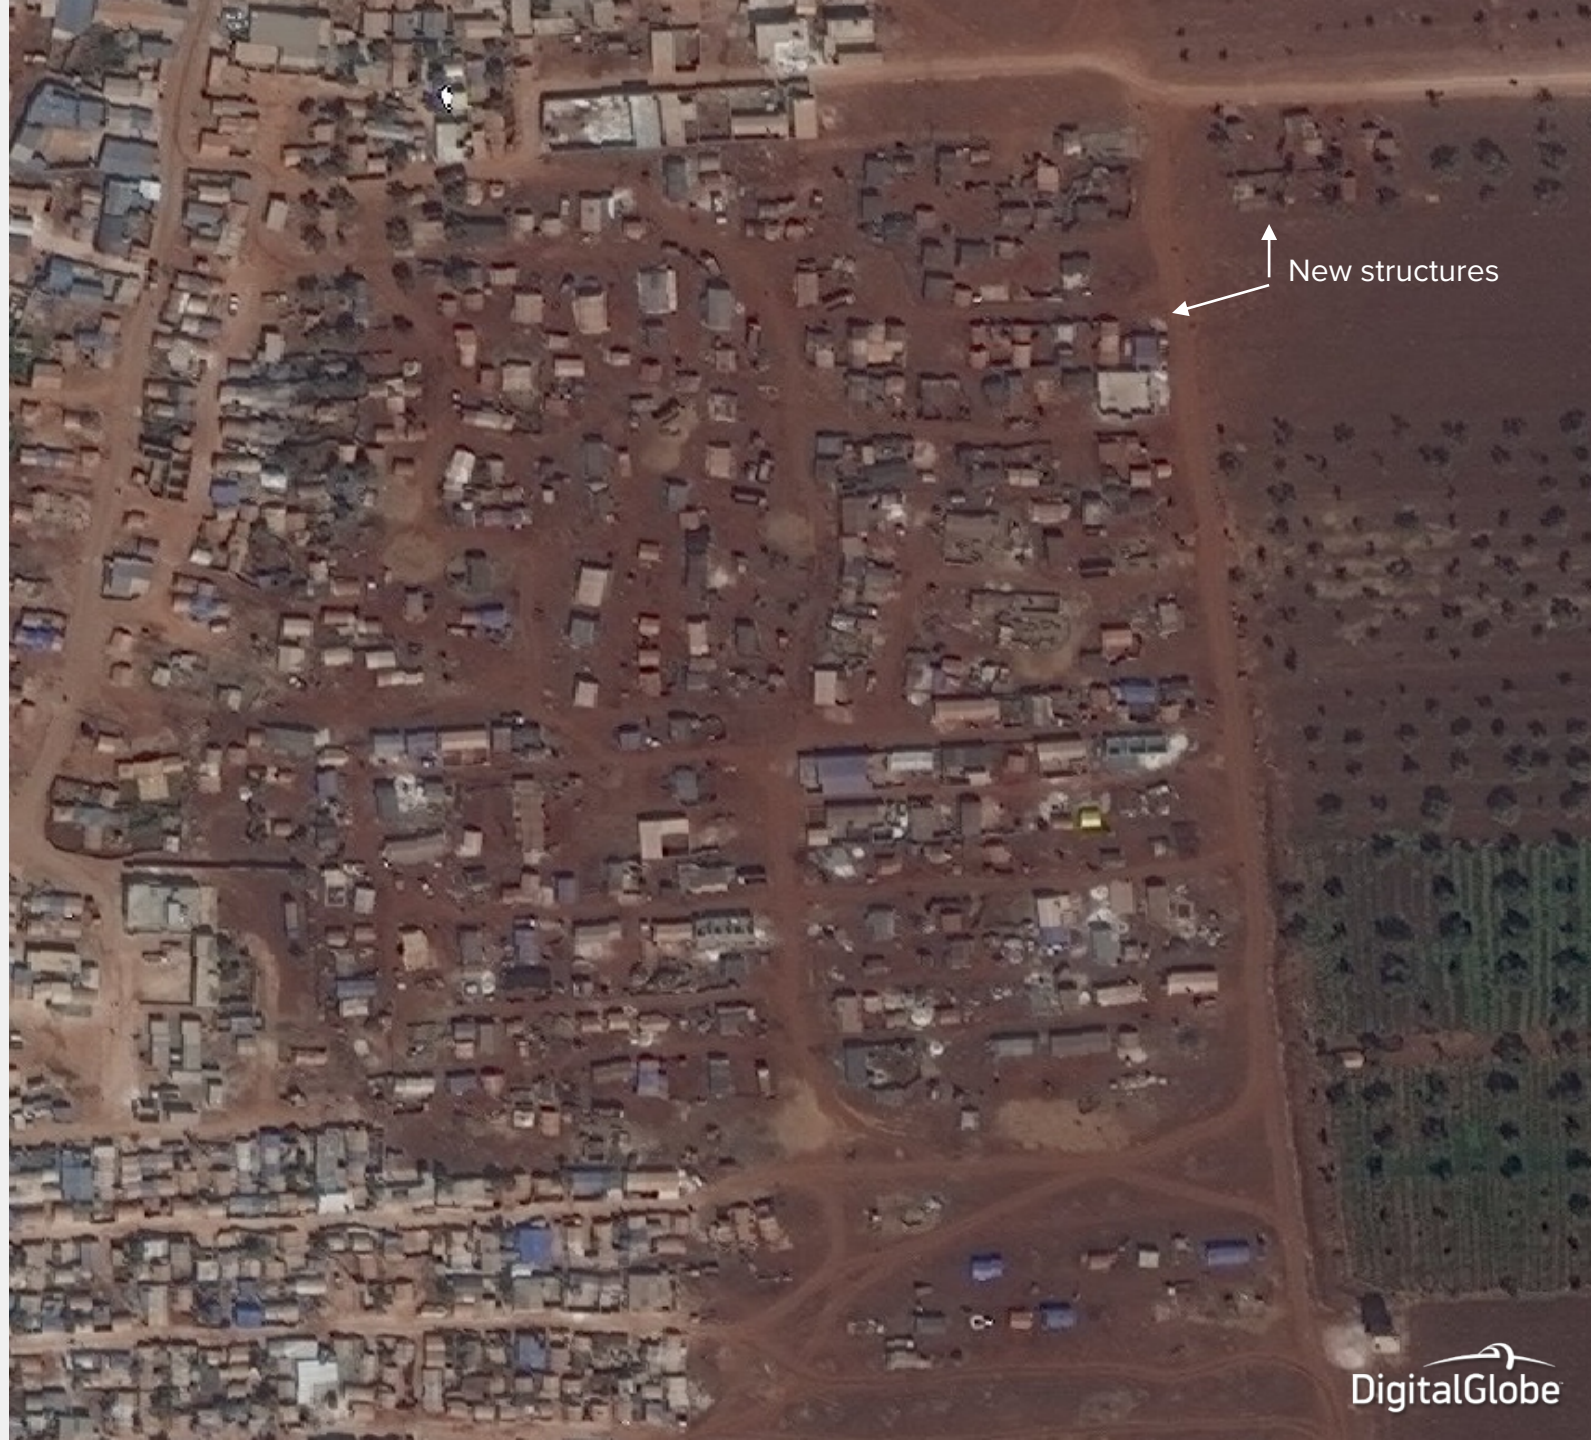
Fig 2.b. IDP Camp, Idlib Governorate
26 September 2018

By September 2018, the previously empty space becomes occupied by several structures consistent with the physical characteristics of a self-settled and spontaneous camp. Several structures appear among the trees beyond the previously unoccupied space.

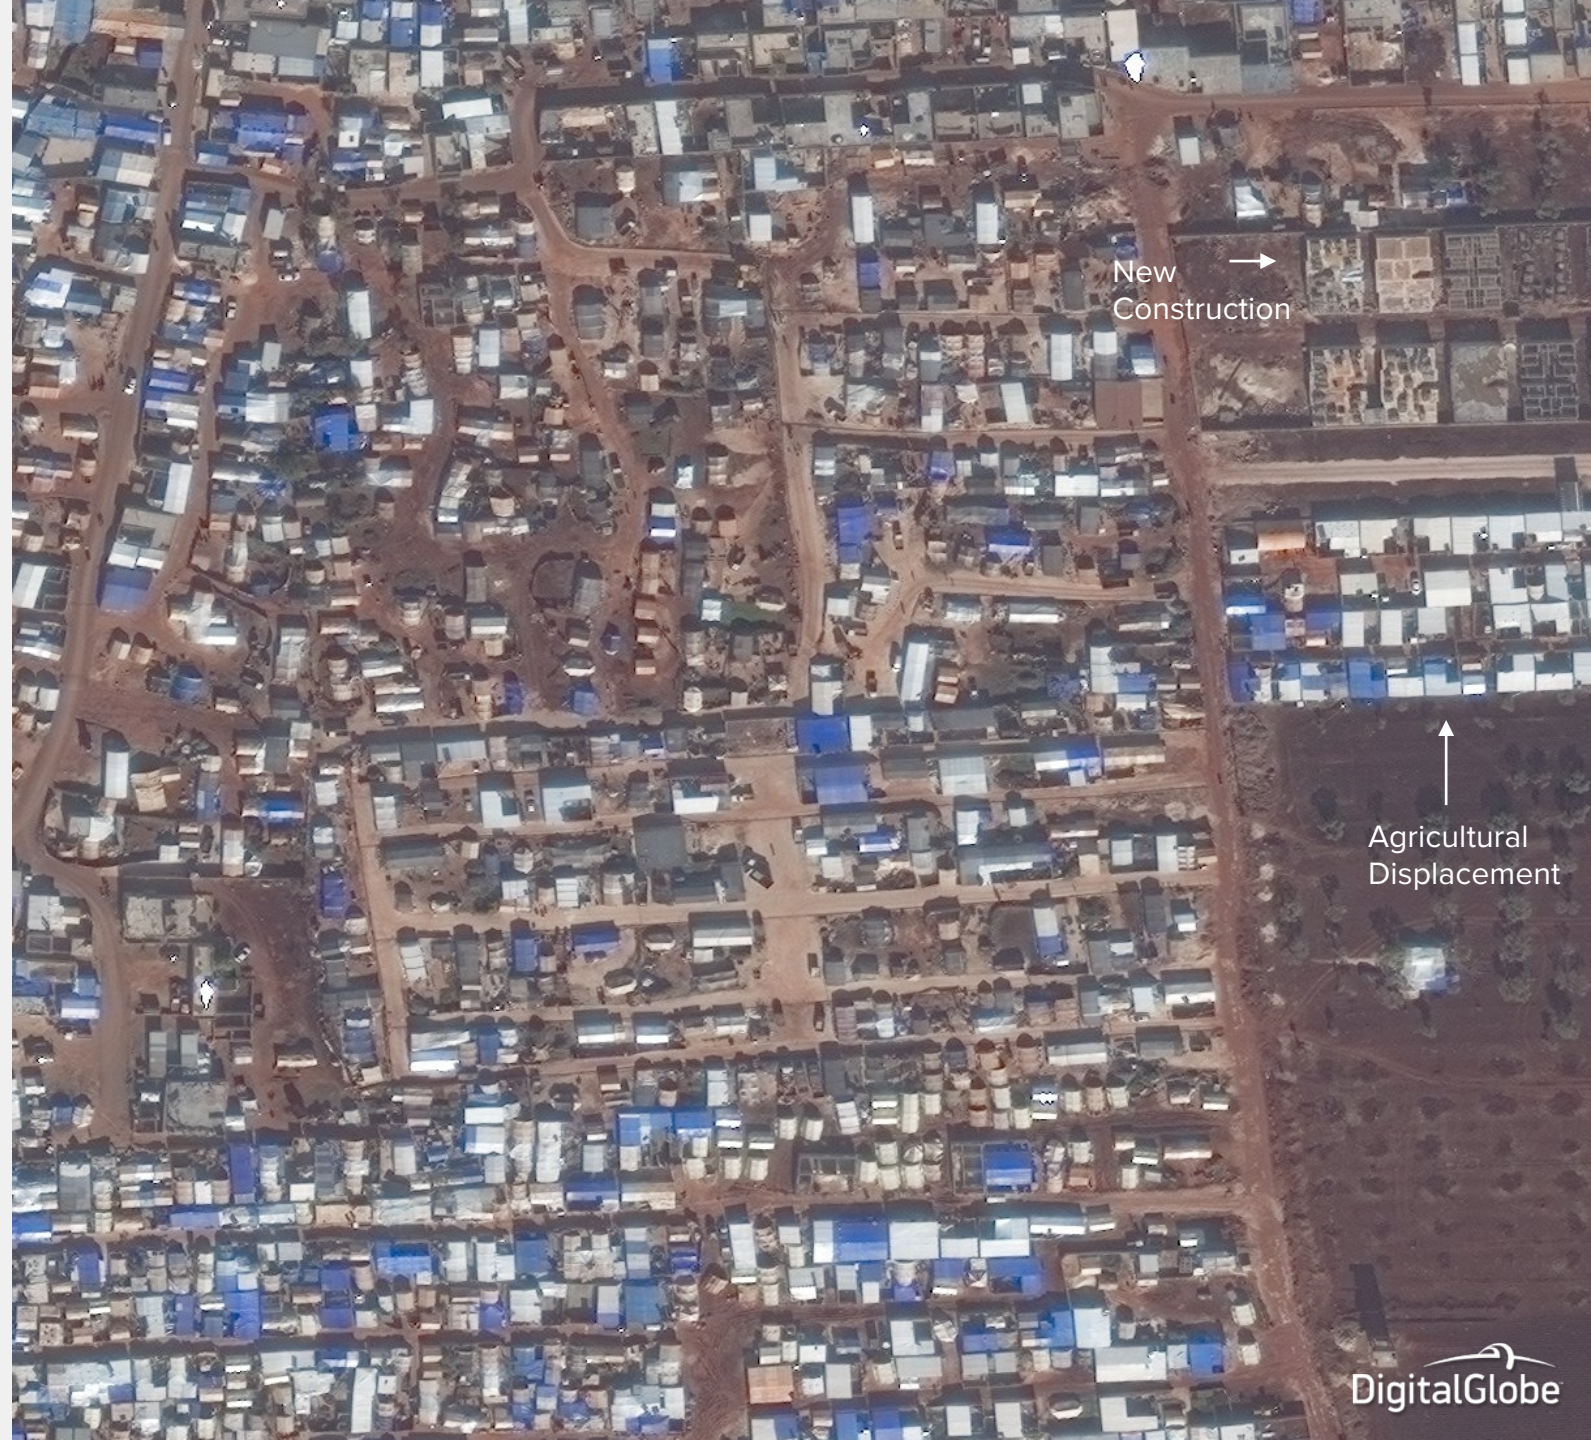
Fig 2.c. IDP Camp, Idlib Governorate
2 December 2019

The temporary structures visible in 2018 appear to have been replaced by larger, more permanent structures with sturdy roofing by December 2019. The area becomes more densely occupied and expansion toward the east replaces agricultural fields still visible in the image captured in September 2018.

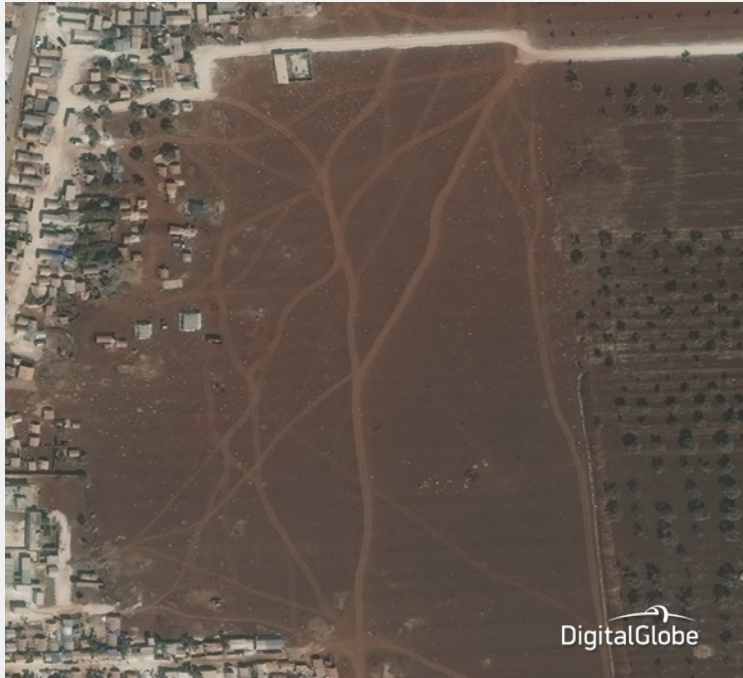
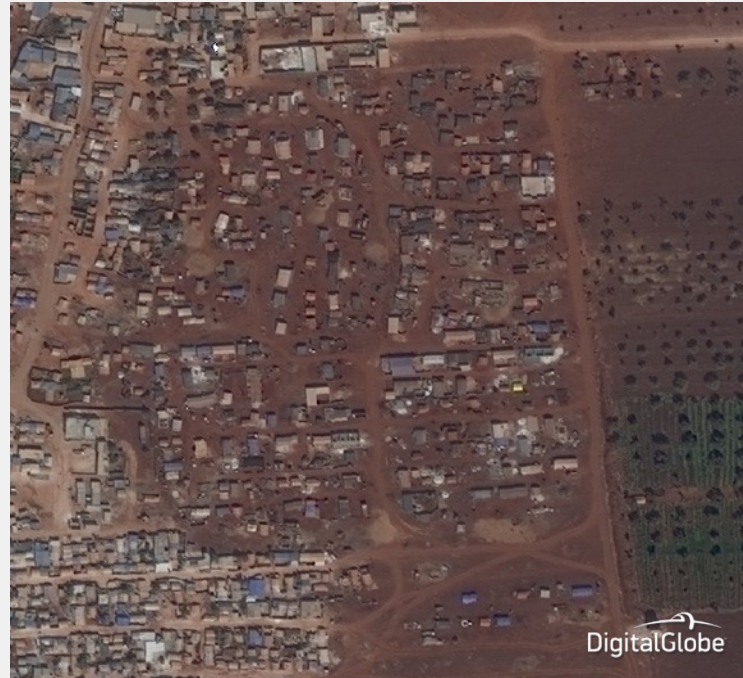
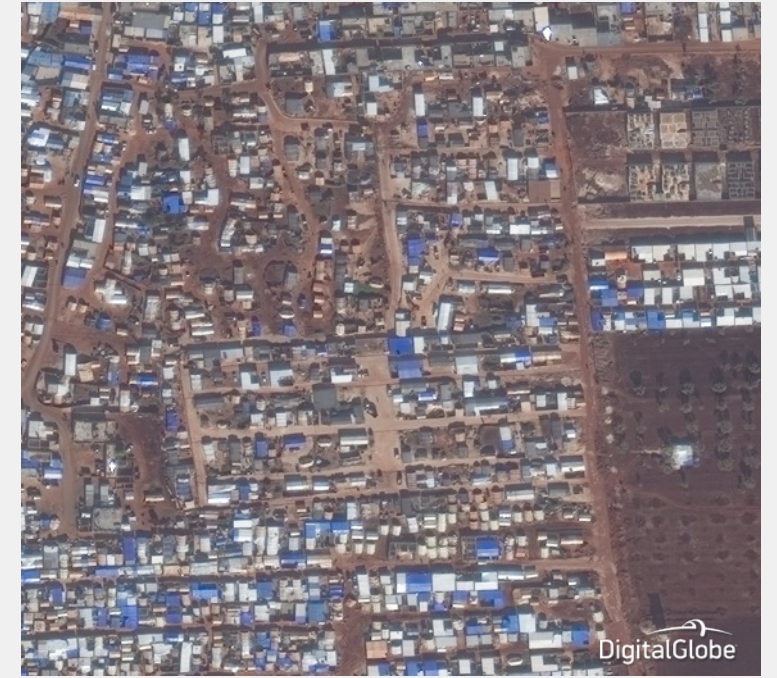
Fig 2.d. Informal to Formal IDP Camp Expansion, Idlib Governorate
Composite of Figs 2a/b/c. Satellite imagery acquired 27 September 2017 (2.a), 26 September 2018 (2.b), 2 December 2019 (2.c).

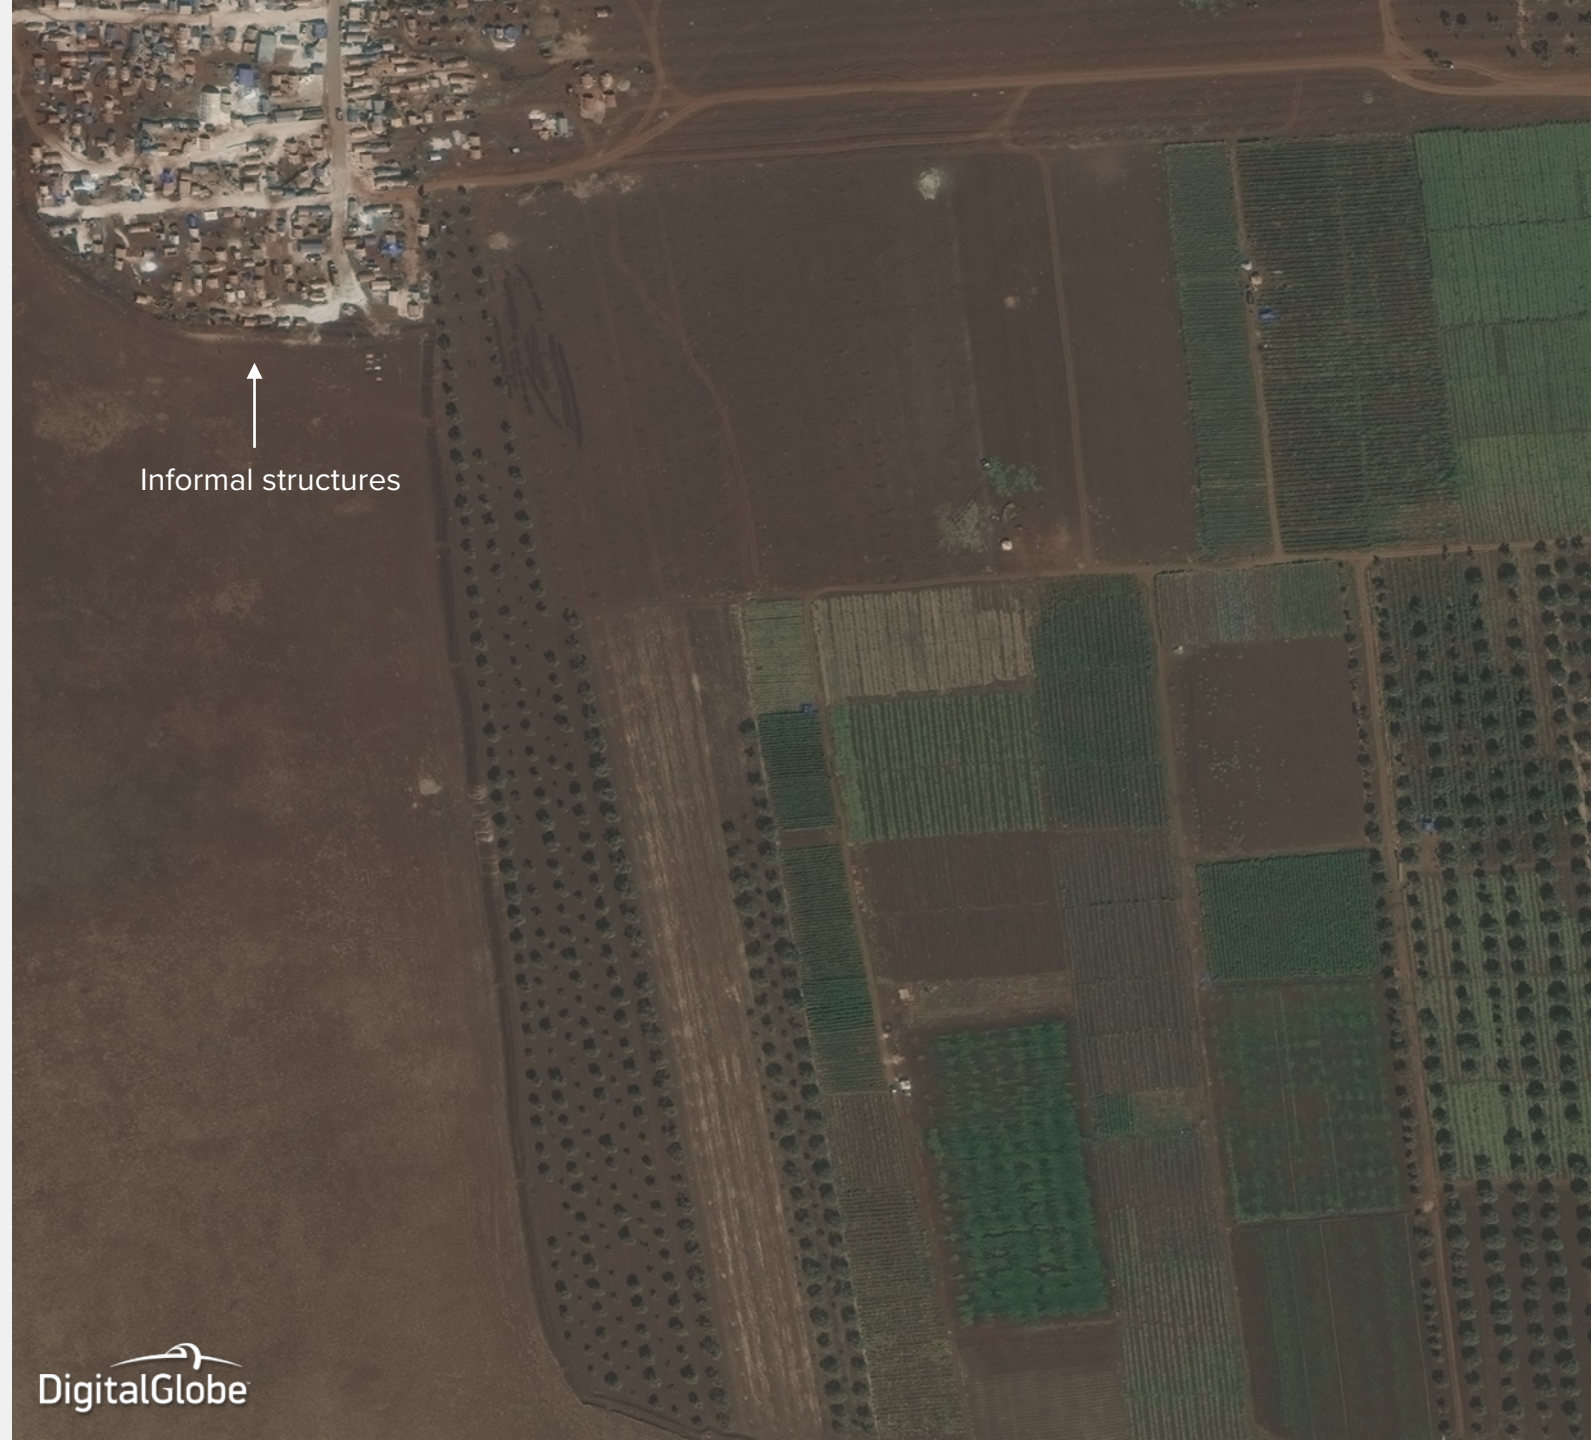
In September 2017, there is a concentration of informal structures in the SW of the camps, near agricultural fields. Several structures are visible throughout the farmed land.

Fig 3.a. IDP camp site and agricultural land, Idlib Governorate
27 September 2017

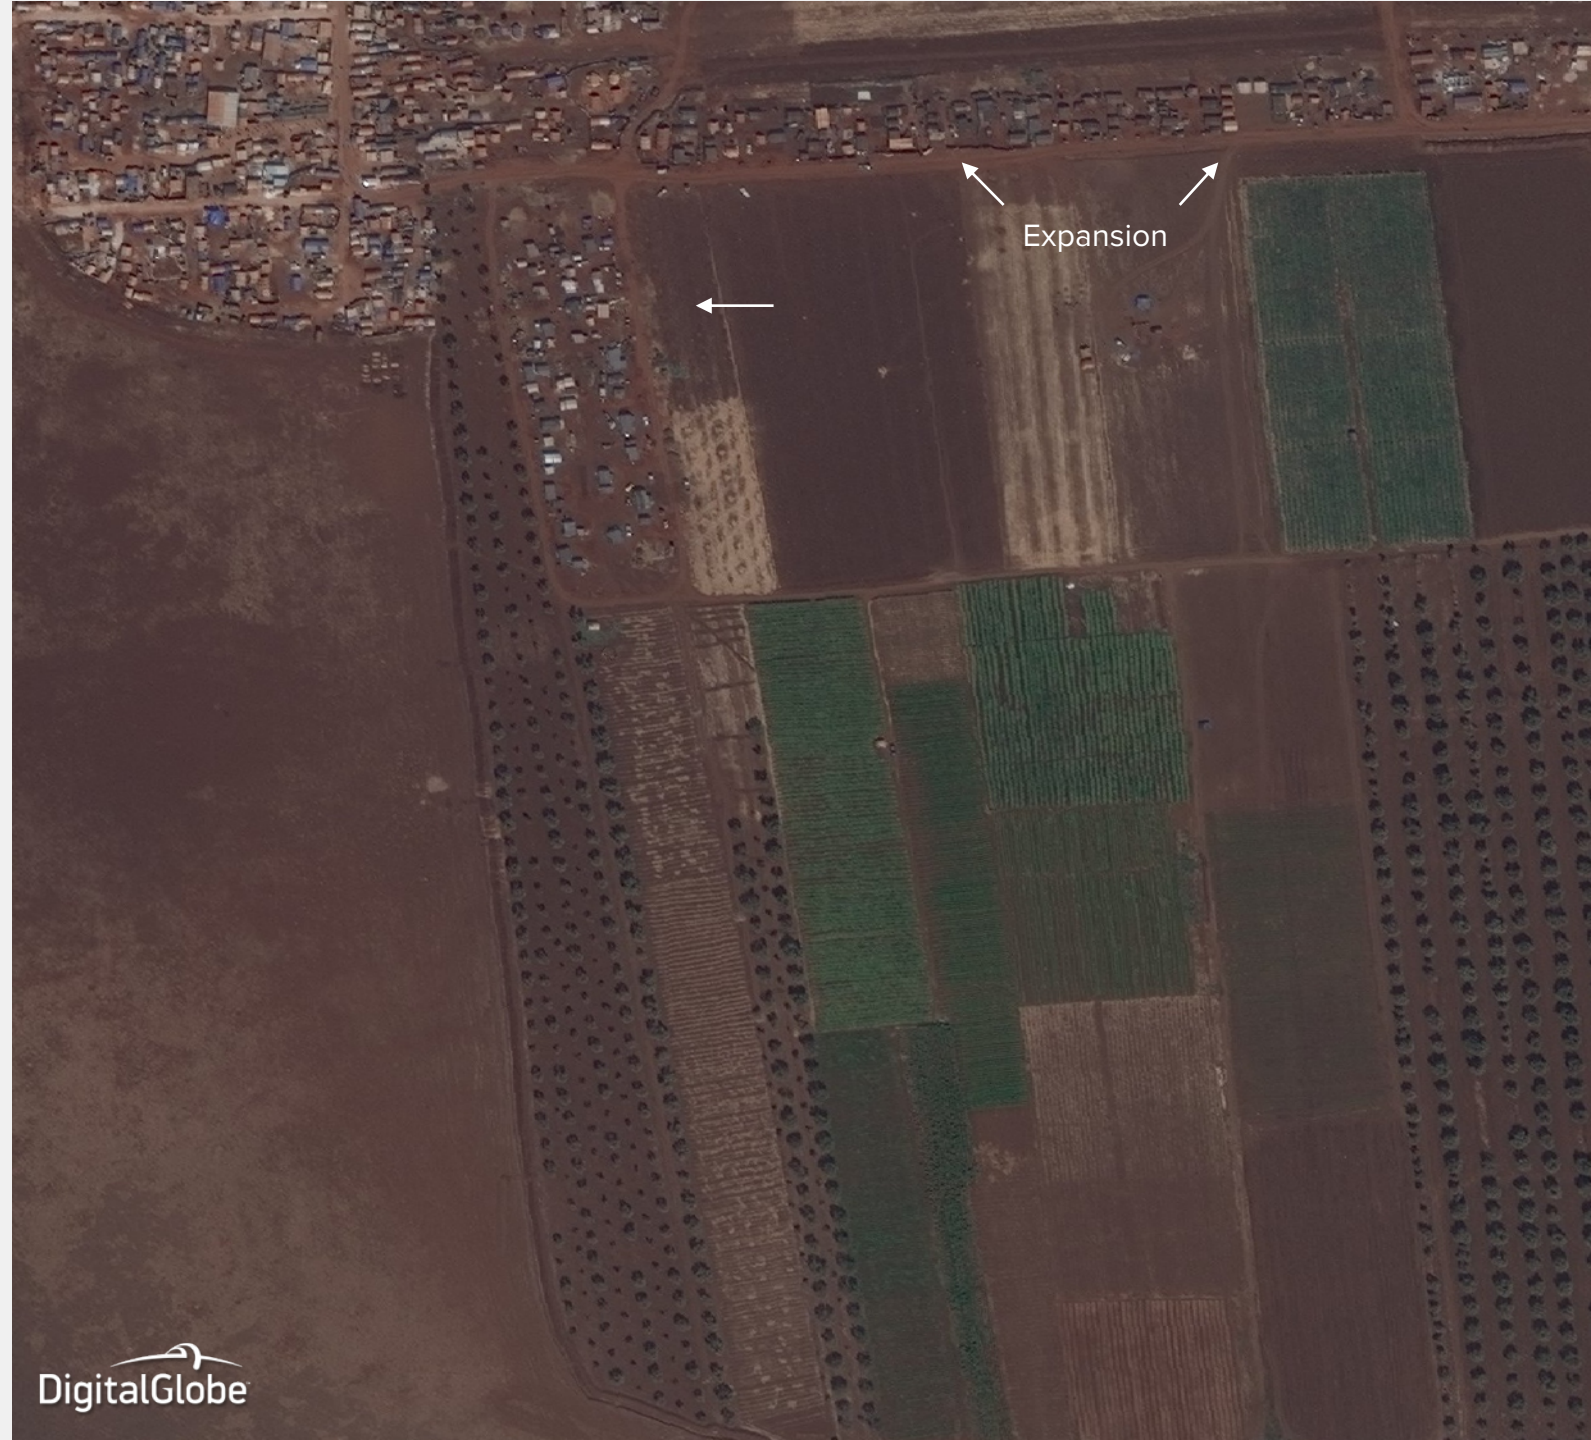
By September 2018, there has been a substantial increase of self-settled populations based close to and often on land that appeared to have formerly been used for agriculture.

Fig 3.b. IDP camp site expansion into agricultural land, Idlib Governorate
26 September 2018
