Displacement & Destruction: Analysis of Idlib, Syria 2017–2020

4 March 2020

Areas of Interest

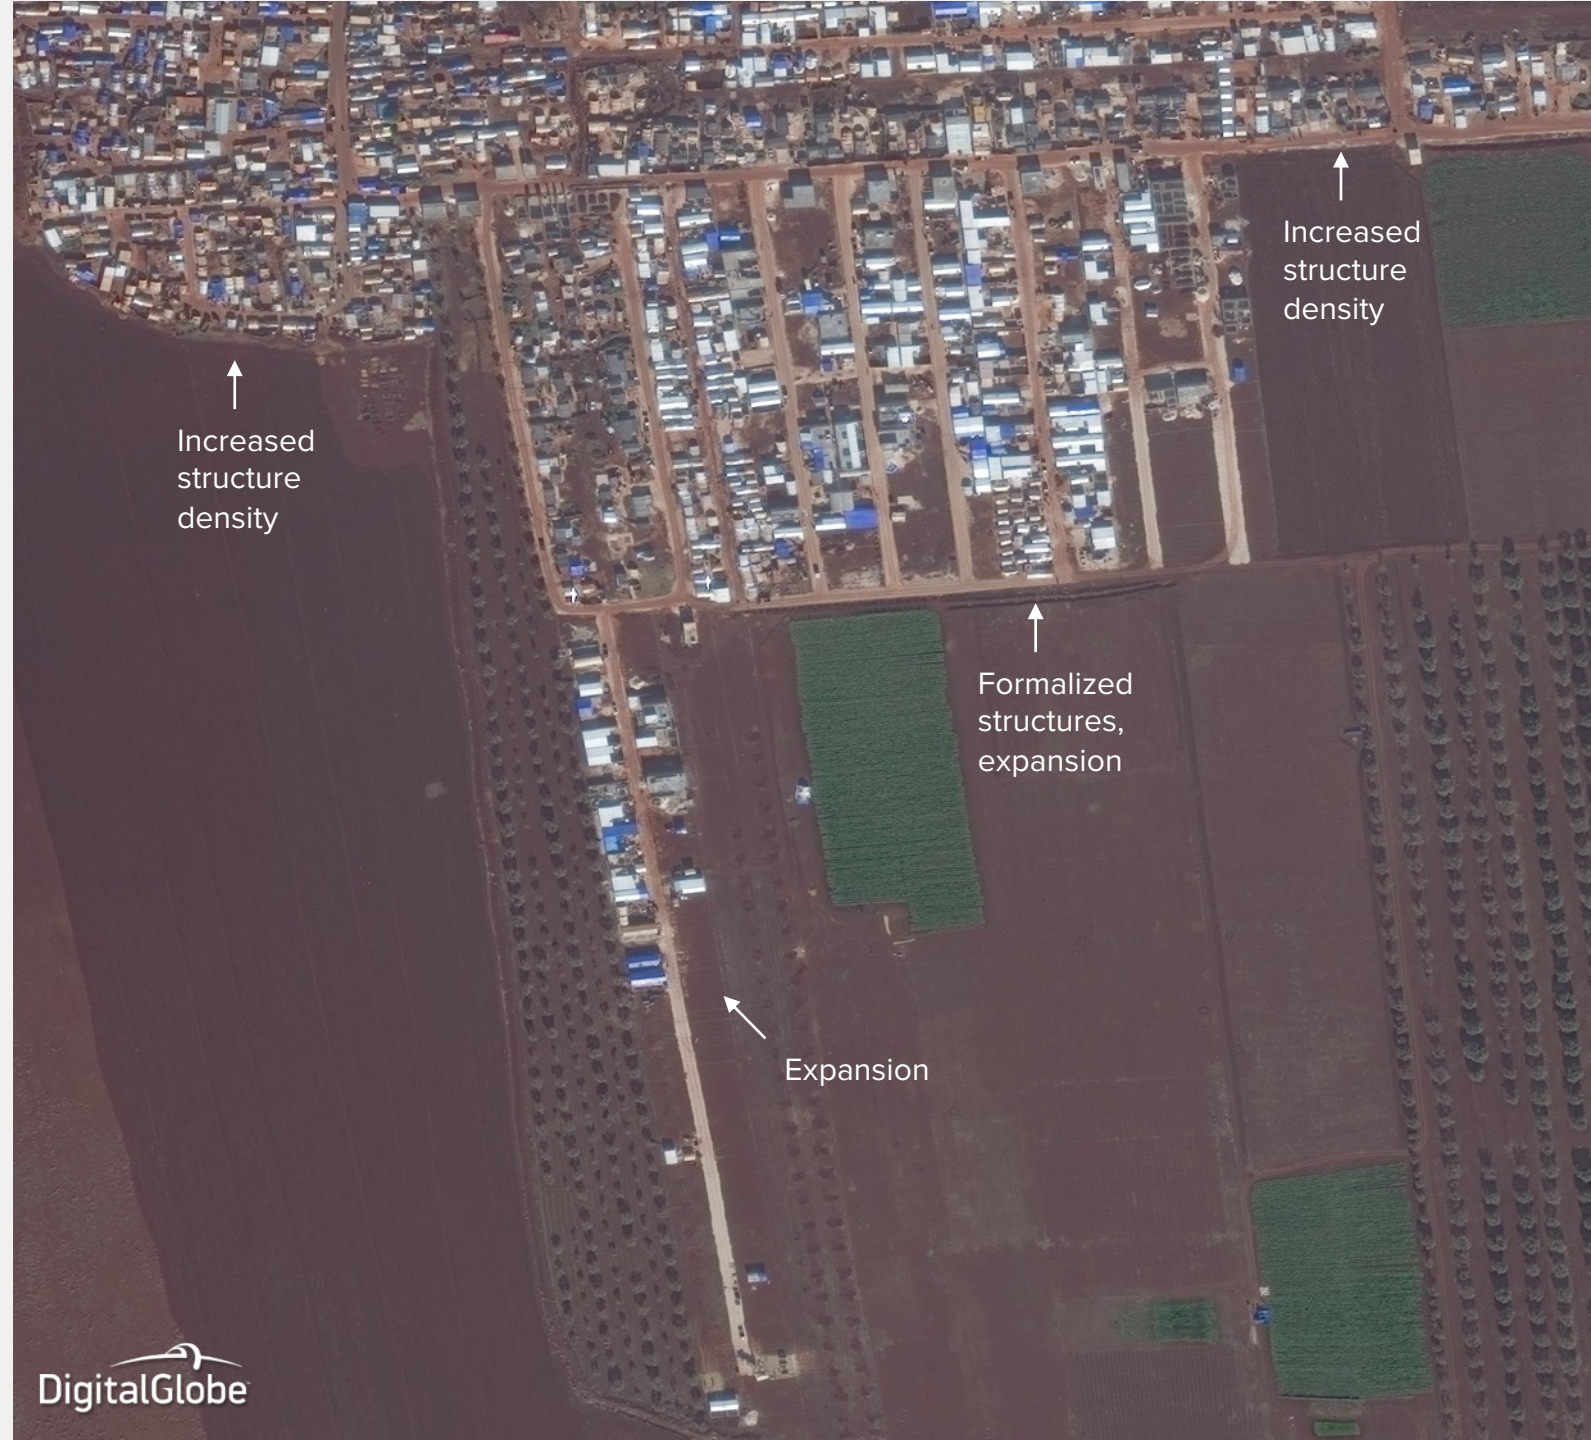
By December 2019, the landscape has substantially changed. The change is consistent with increased structure density, structure formalization, camp expansion, and conversion of agricultural land.

Fig 3.c. IDP camp site formalization, expansion into agricultural land, Idlib Governorate
2 December 2019

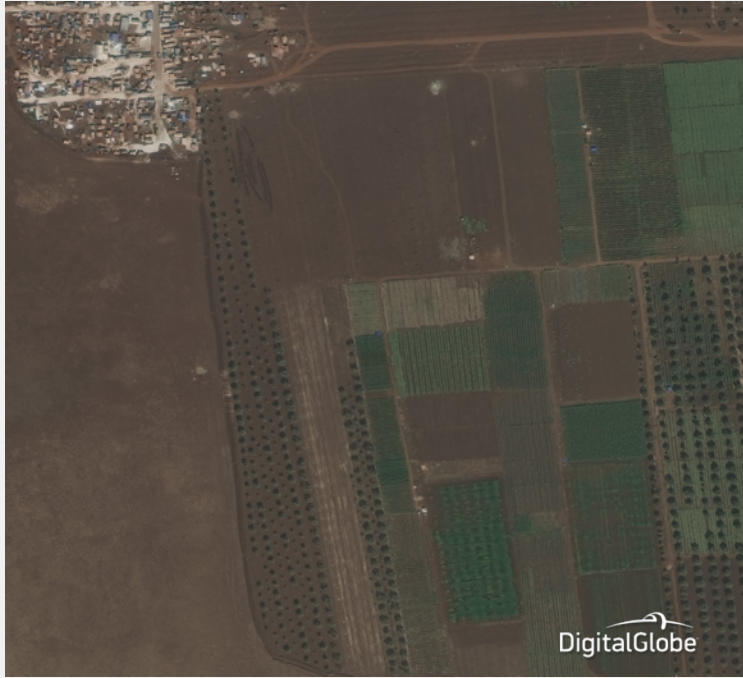
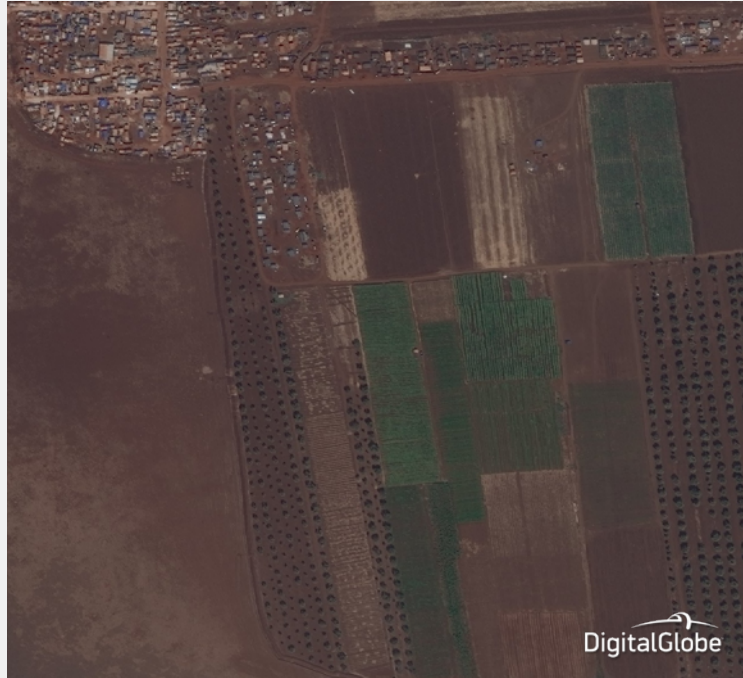
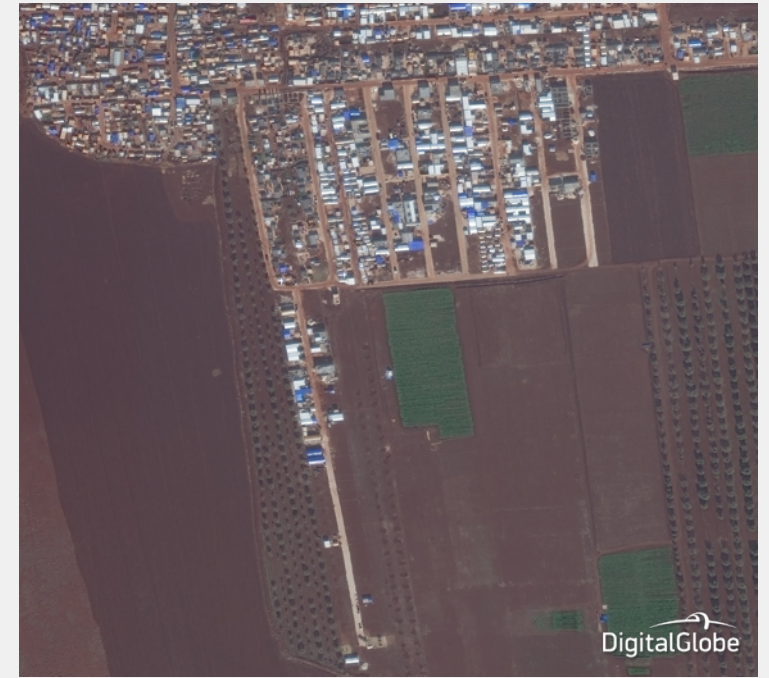
Fig 3.d. IDP camp expansion into former agricultural land, 2017-2019, Idlib Governorate
Composite of Figs 3a/b/c. Satellite imagery acquired 27 September 2017 (3.a), 26 September 2018 (3.b), 2 December 2019 (3.c).
Satellite imagery ©2020 DigitalGlobe

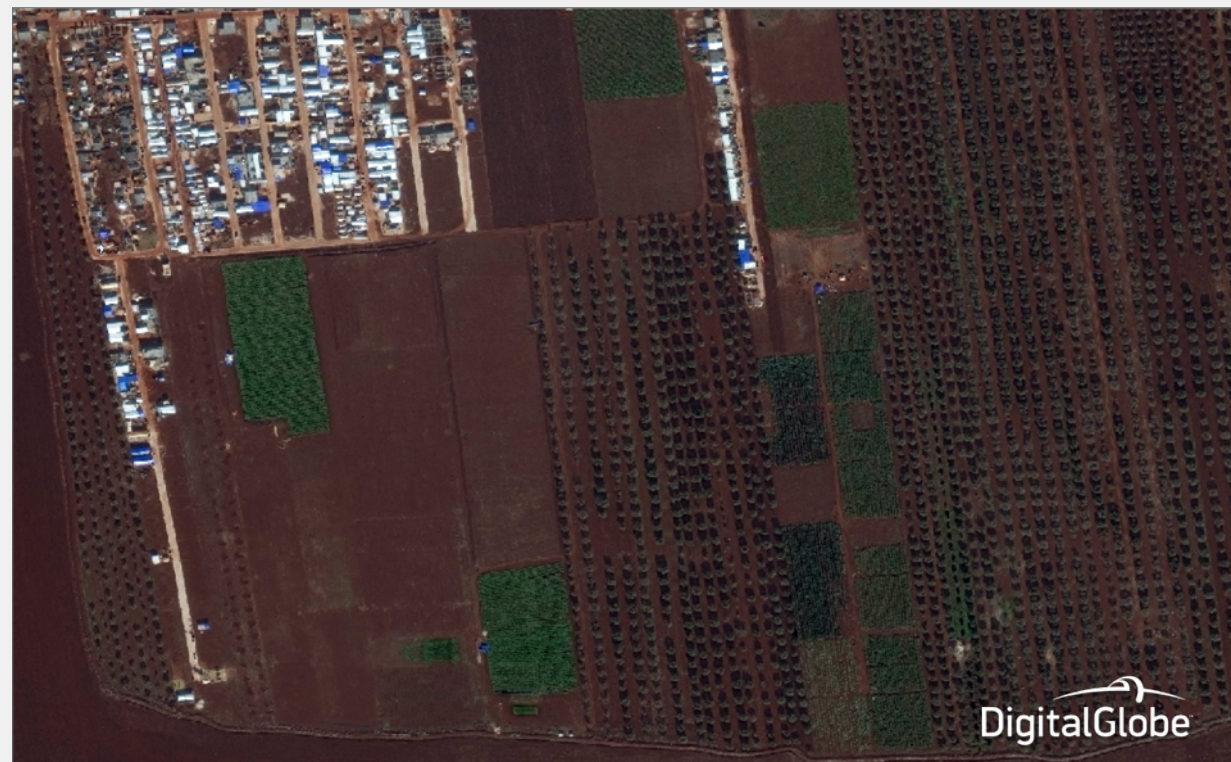
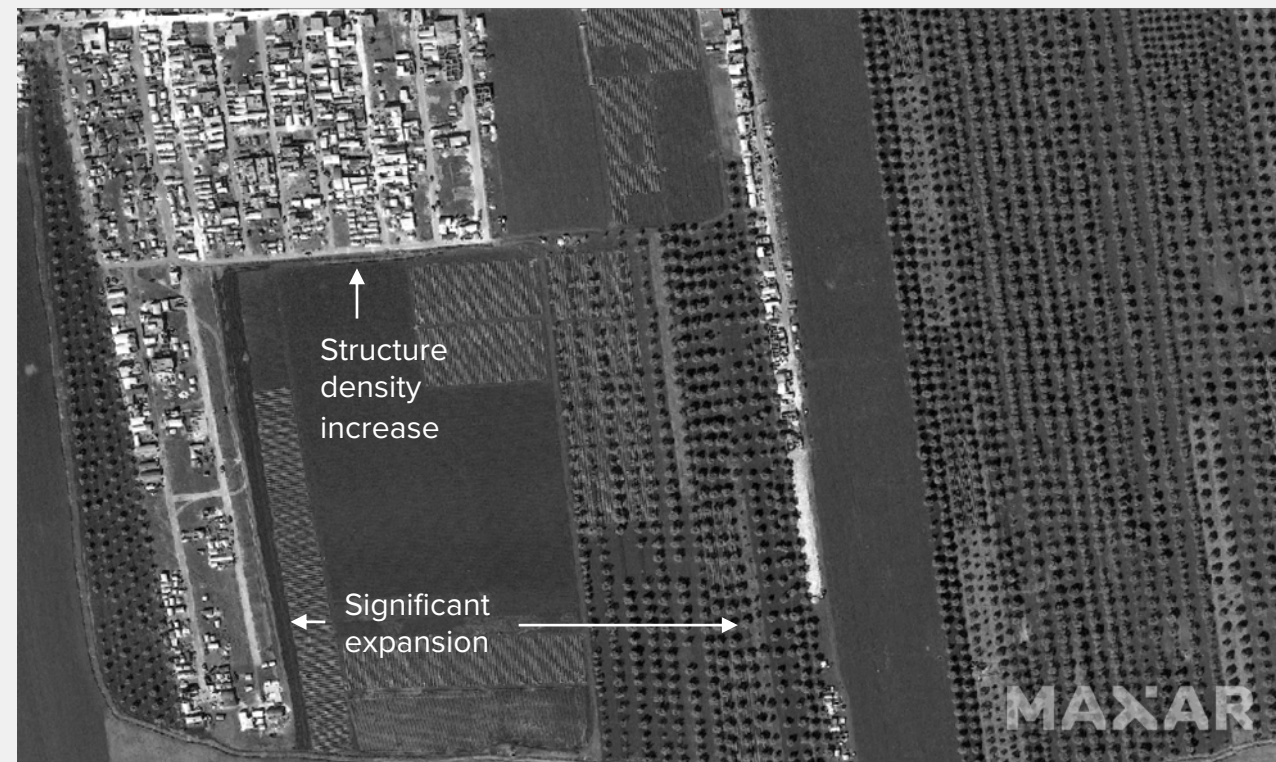
Fig 3.e. IDP camp expansion into former agricultural land over 86 days, Dec 2019 – Feb 2020, Idlib Governorate
In less than three months, structure density and settlement area expands significantly. IDPs who may be sheltering among agriculture groves, without tarps or other cover, cannot be identified using satellite imagery alone. The apparent expansion may underrepresent the real population growth at this site.

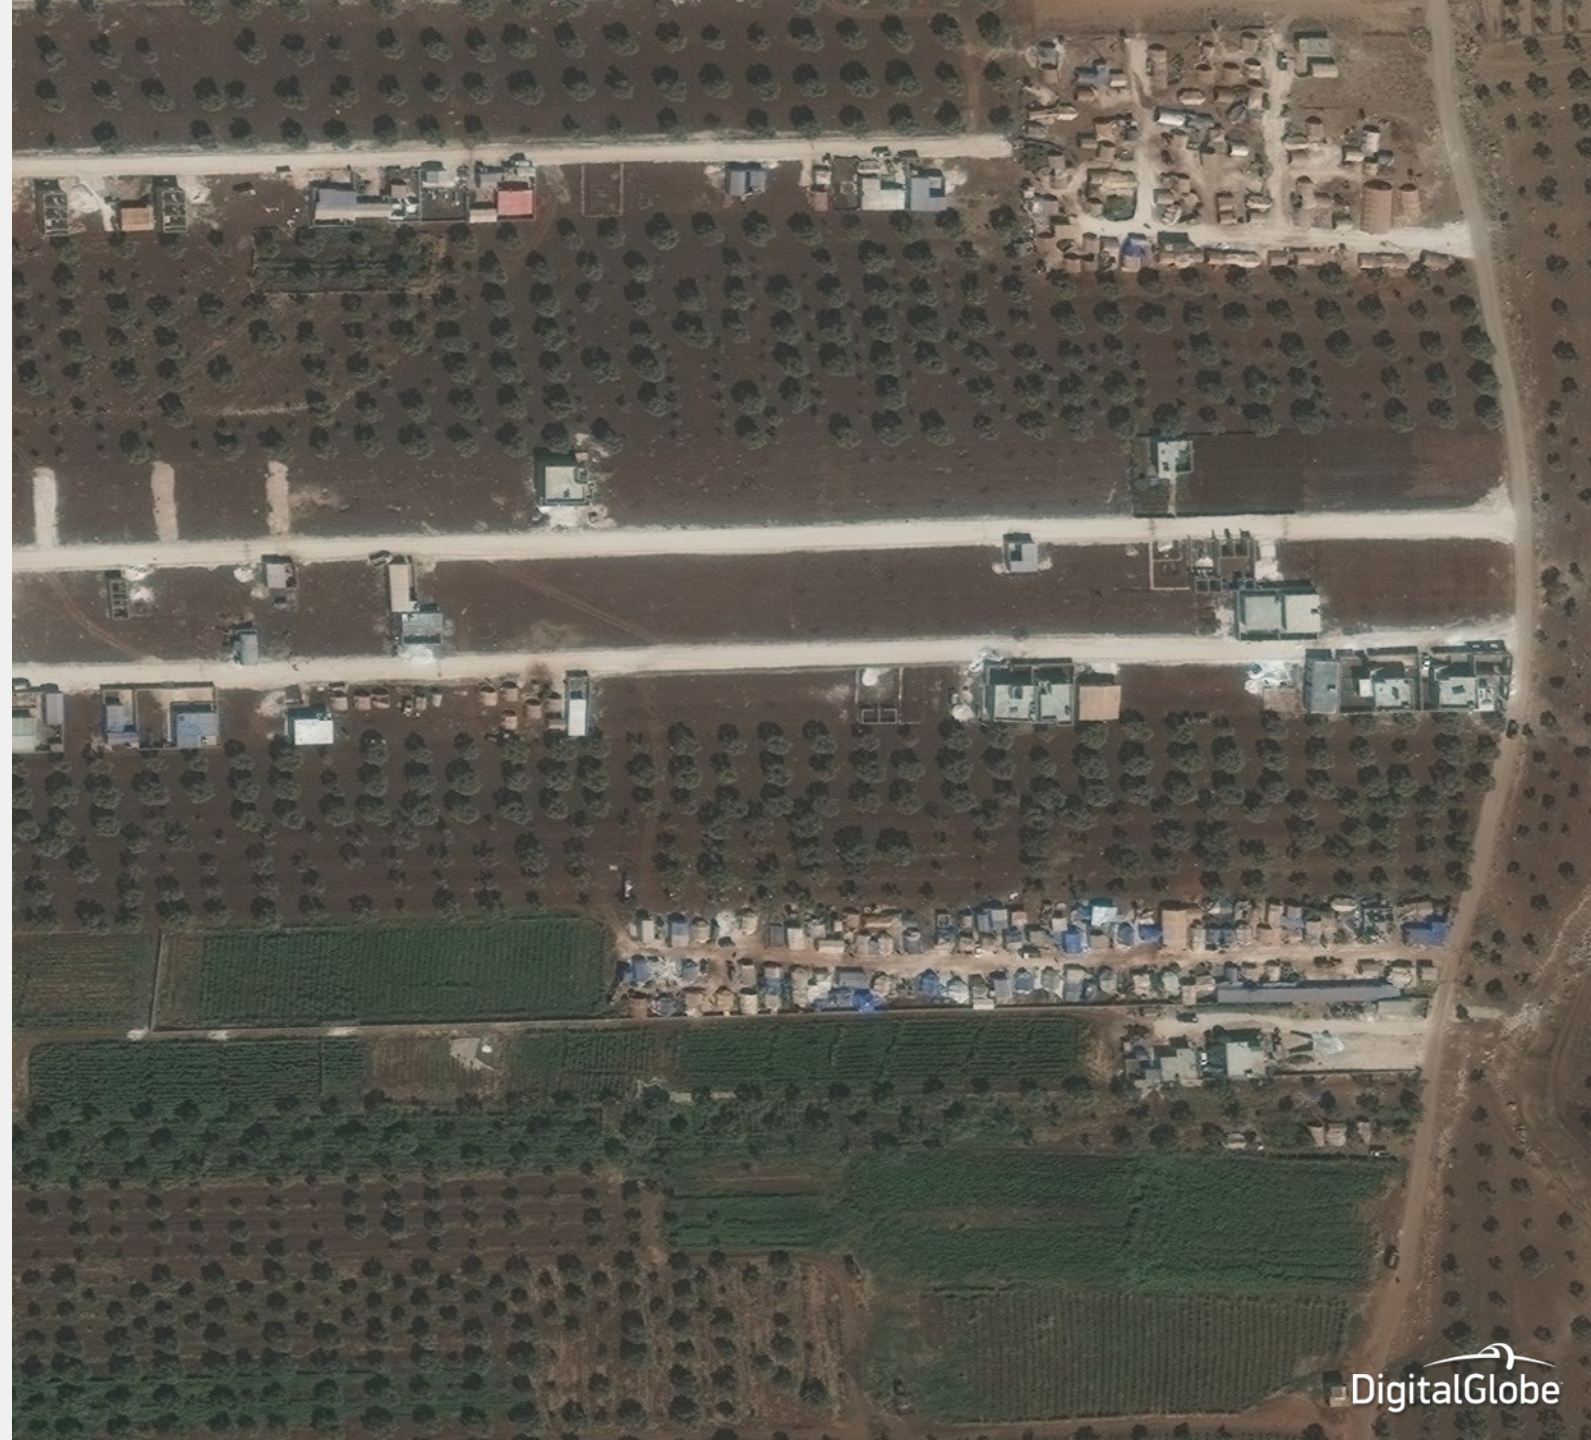
Parts of the camp appear to be formalized and organized, with apparent connecting roads throughout.

Fig 4.a. IDP camp site and agricultural land, Idlib Governorate
27 September 2017

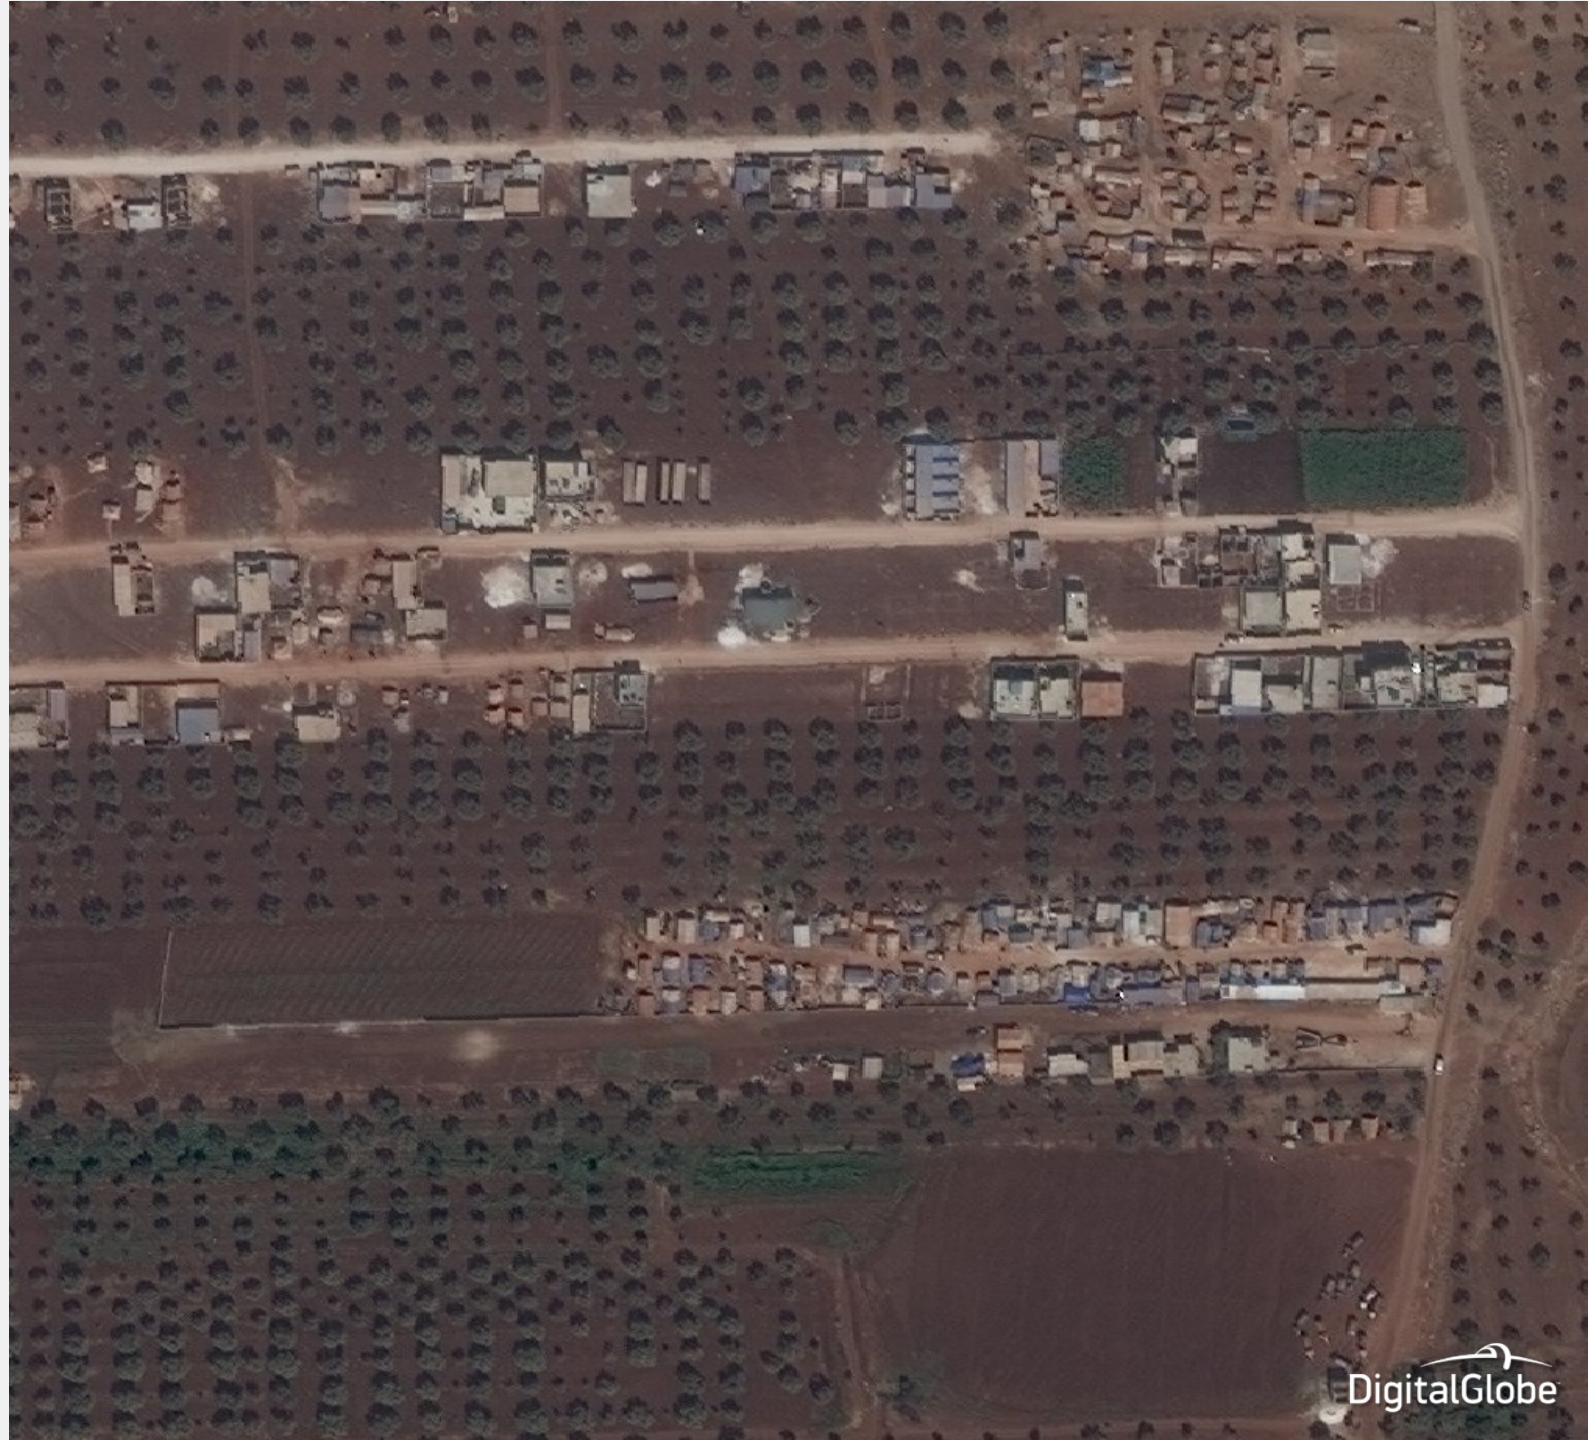
By September 2018, areas that were previously unoccupied appear to be undergoing construction and there appears to be additional small structures clustered in various areas.

Fig 4.b. IDP camp site expansion into agricultural land, Idlib Governorate 26 September 2018

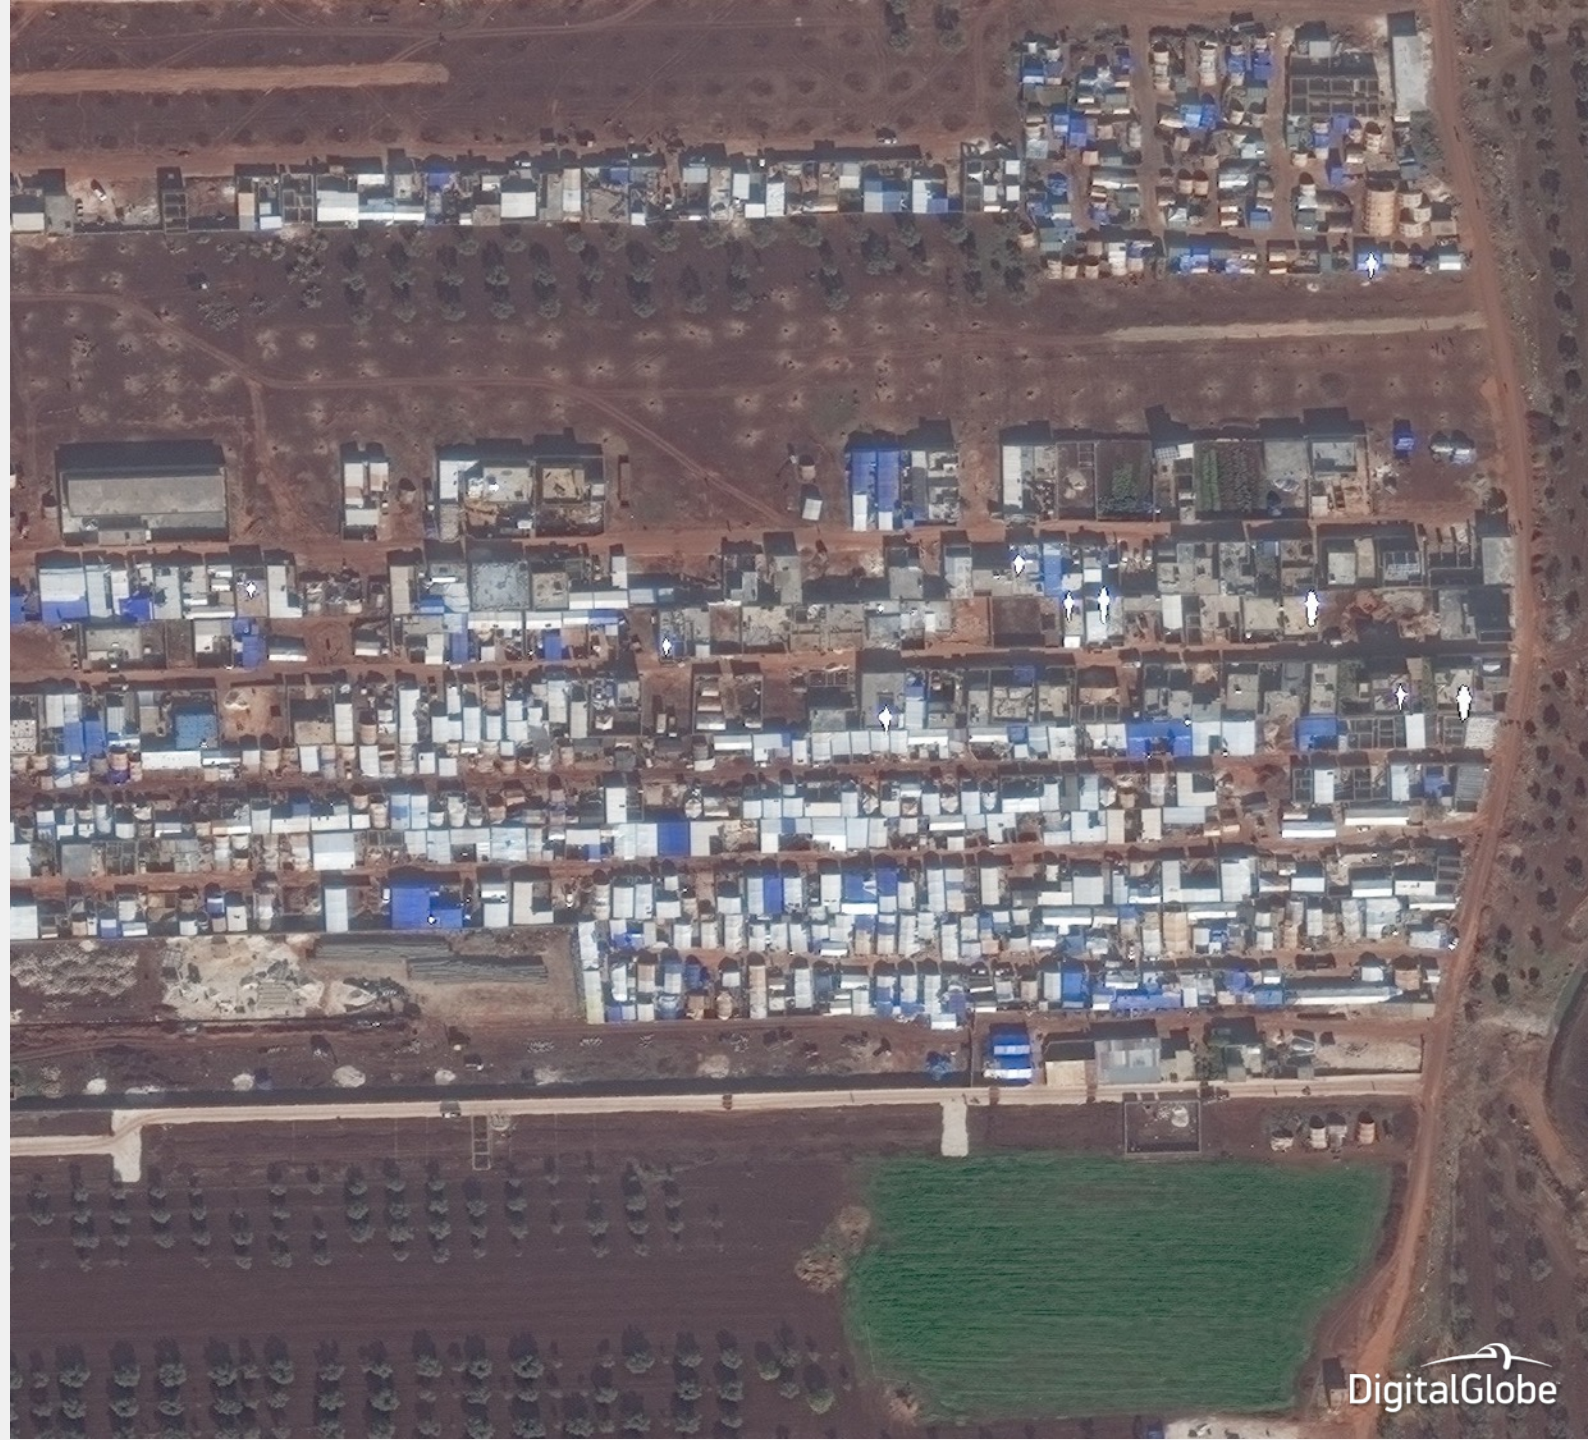
As seen in previous figures, by December 2019 there appears to be substantial formalization of structures as well as additional development. Where trees previously stood in September 2018 now mirror physical characteristics that are consistent with upturned earth, suggest that the trees may have been removed.

Fig 4.c. IDP camp site formalization, expansion into agricultural land, Idlib Governorate
2 December 2019

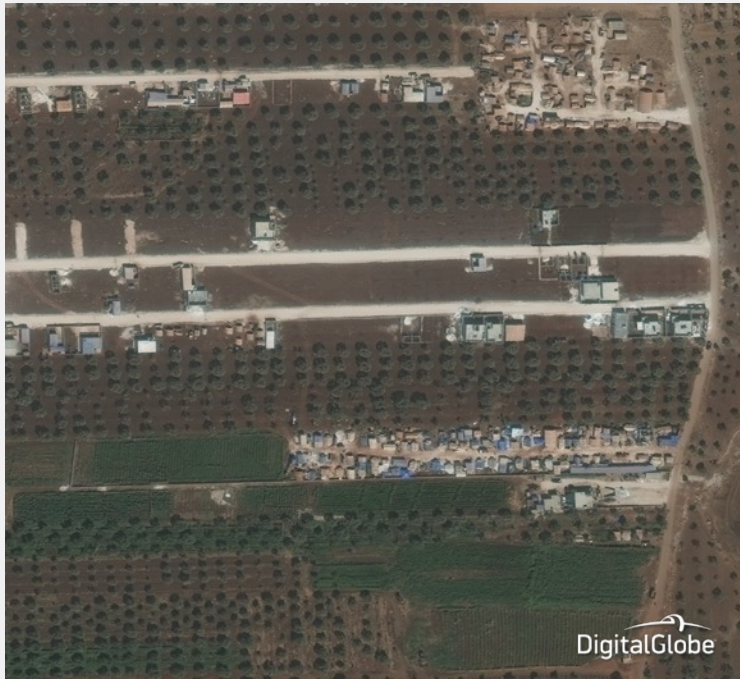
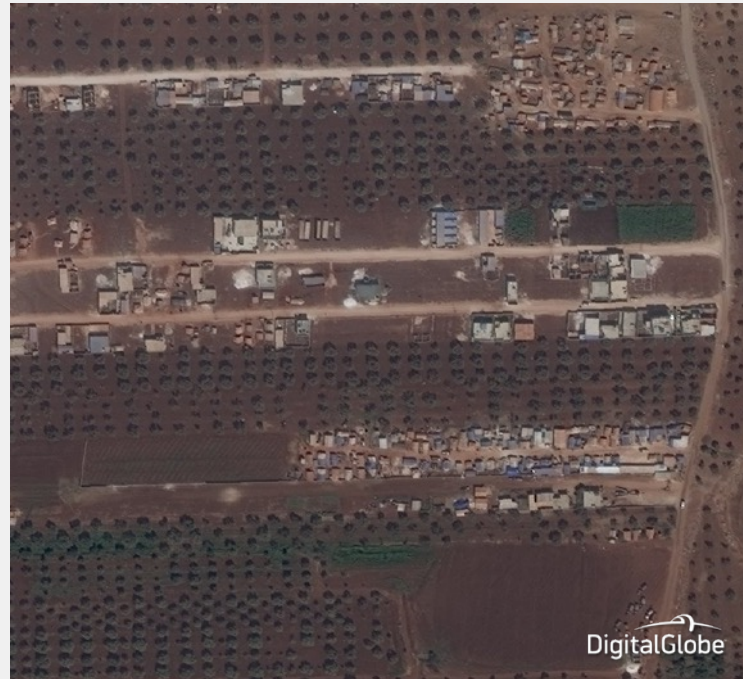
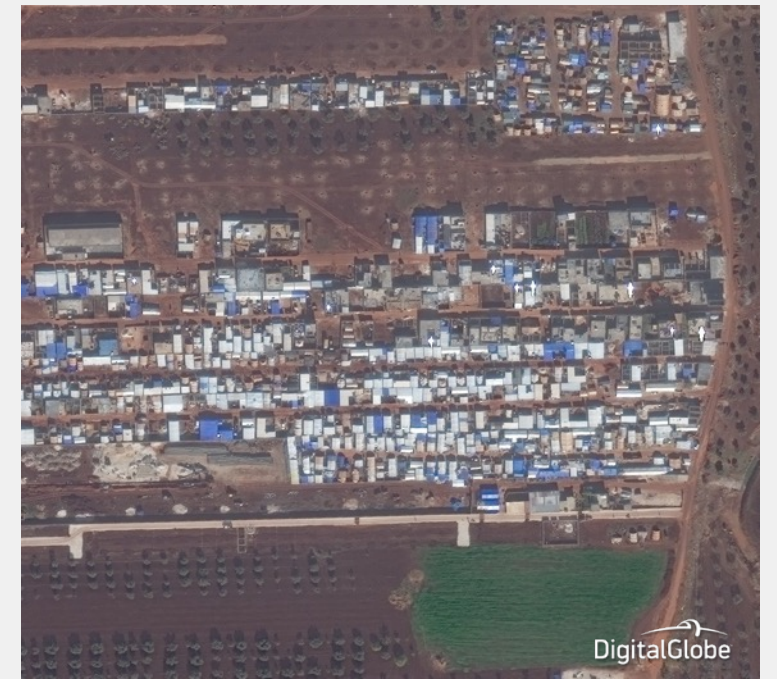
Fig 4.d. IDP camp expansion into former agricultural land, 2017-2019, Idlib Governorate
Composite of Figs 4a/b/c. Satellite imagery acquired 27 September 2017 (3.a), 26 September 2018 (3.b), 2 December 2019 (3.c).

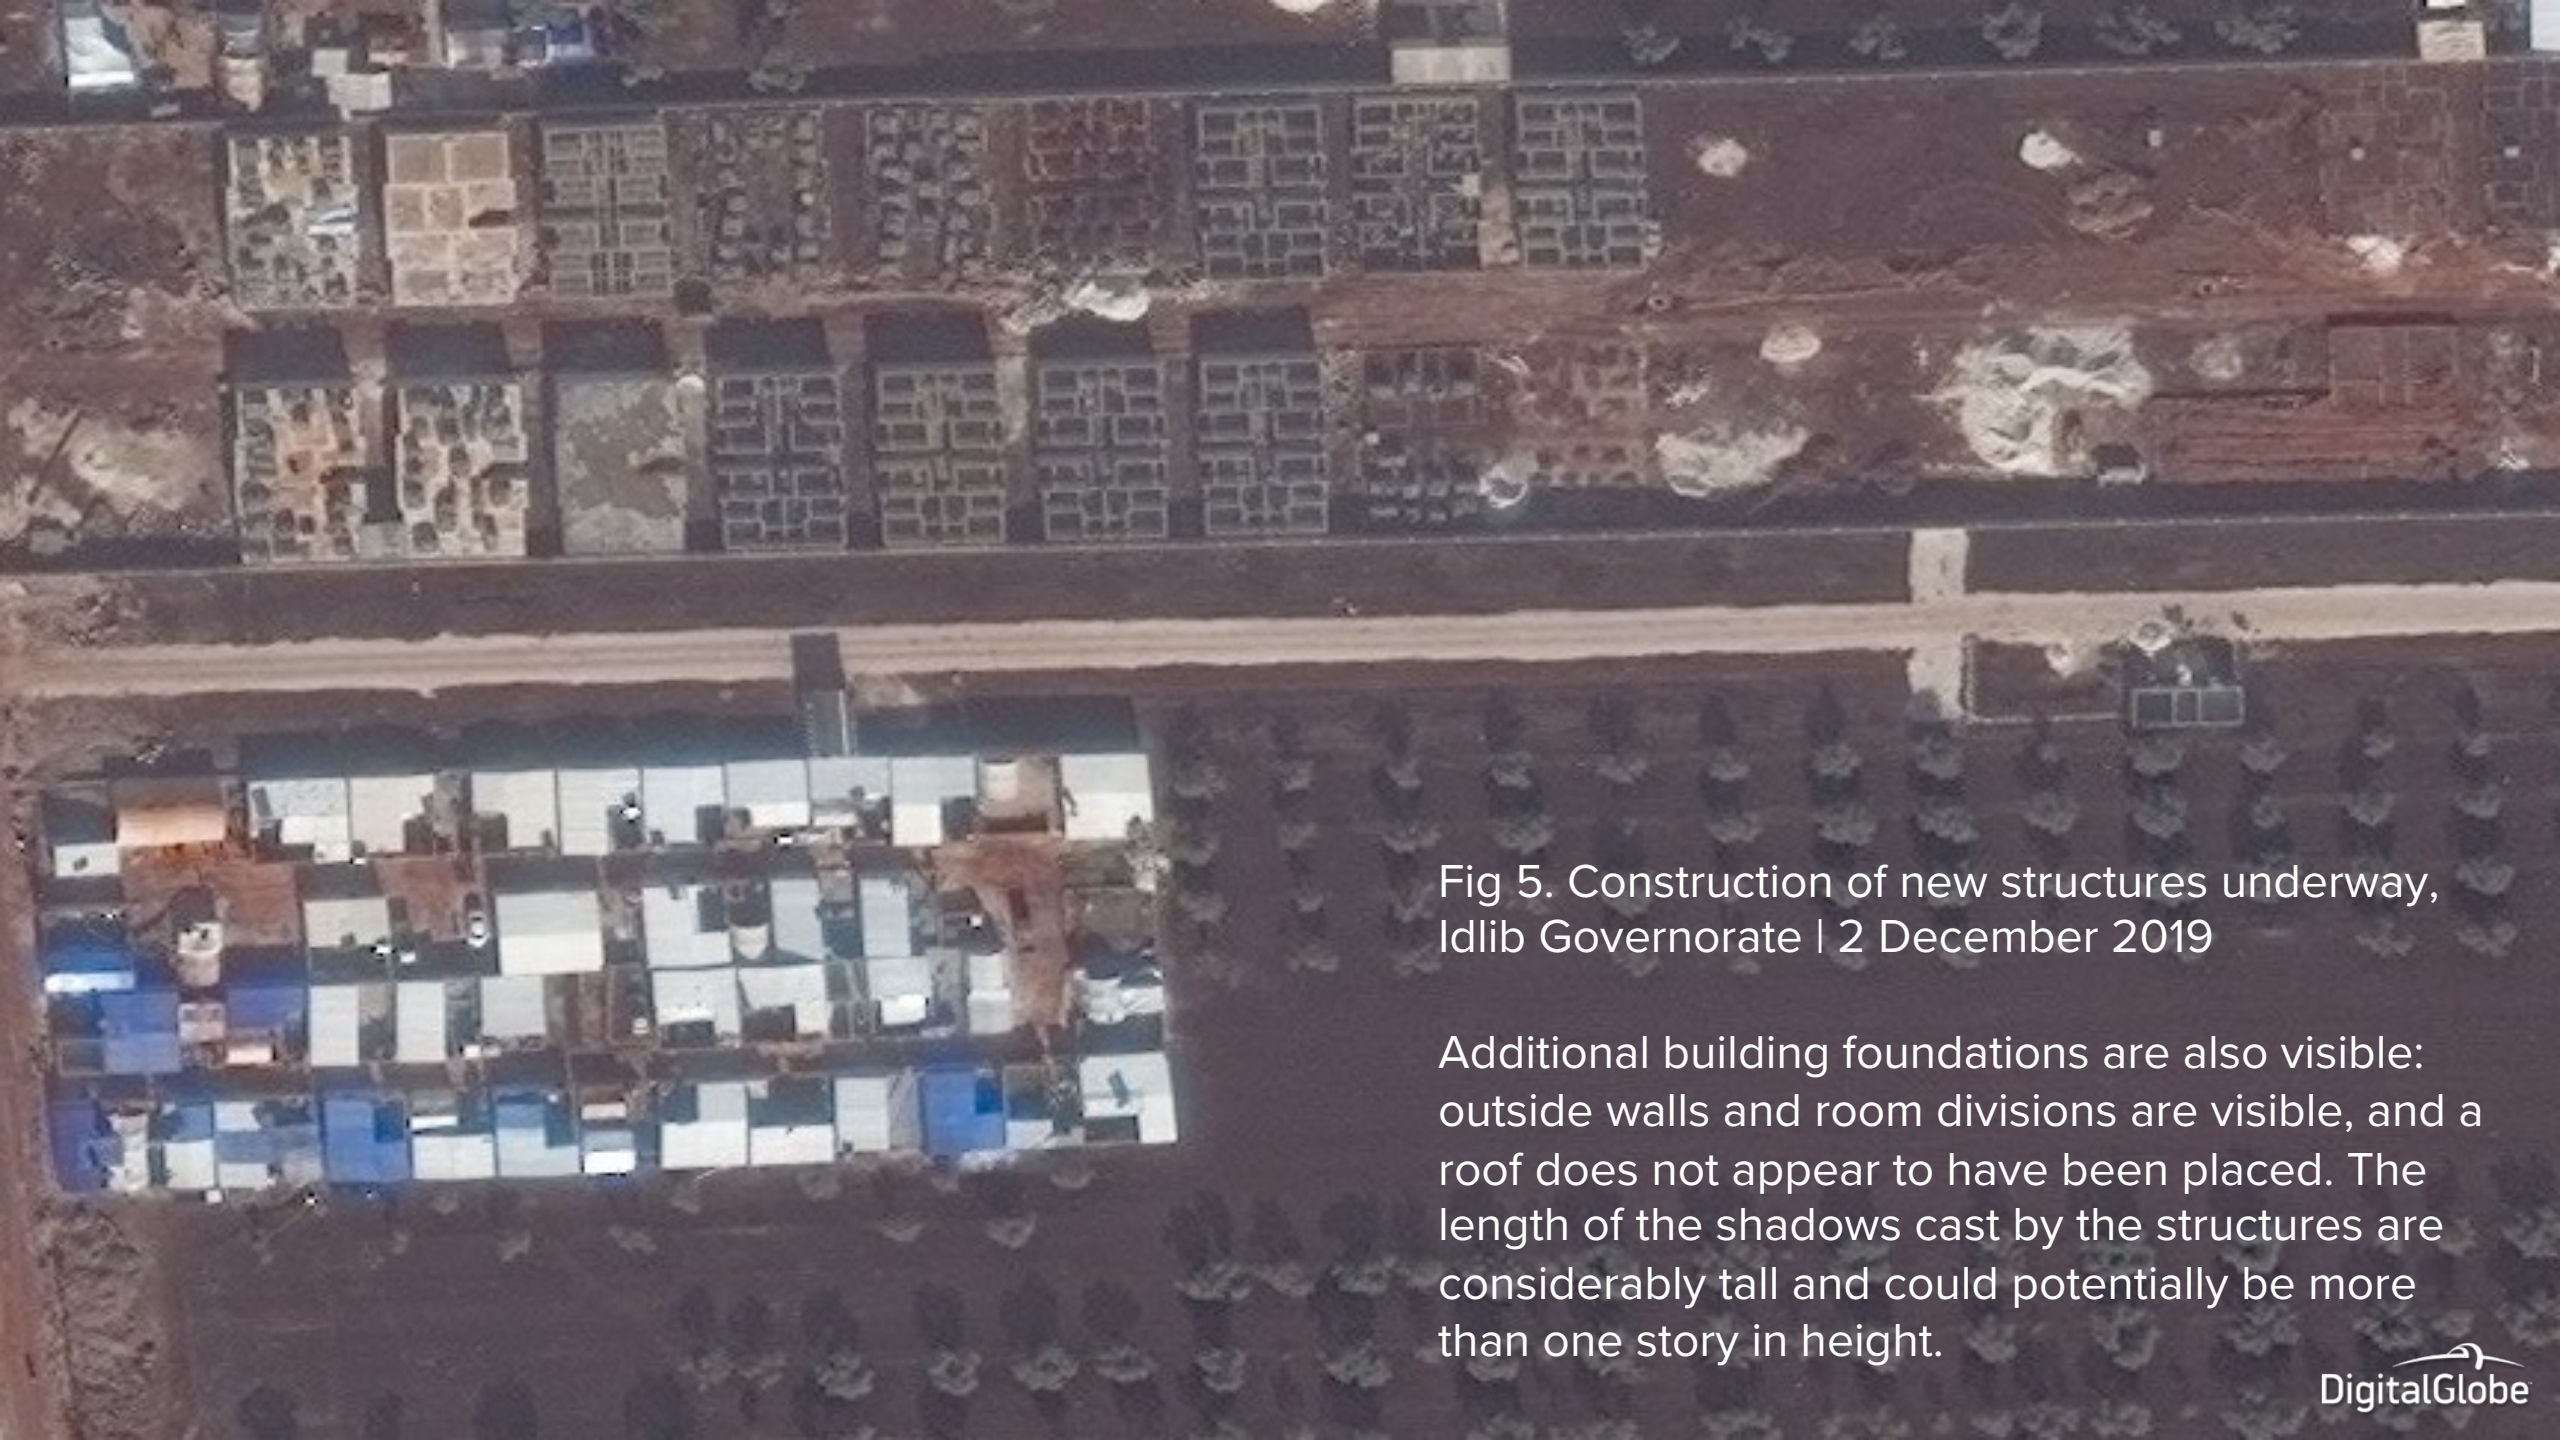
Fig 5. Construction of new structures underway, Idlib Governorate | 2 December 2019

Additional building foundations are also visible: outside walls and room divisions are visible, and a roof does not appear to have been placed. The length of the shadows cast by the structures are considerably tall and could potentially be more than one story in height.

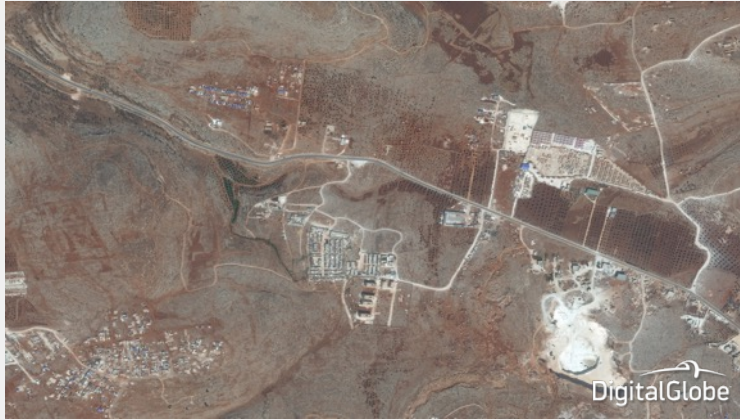
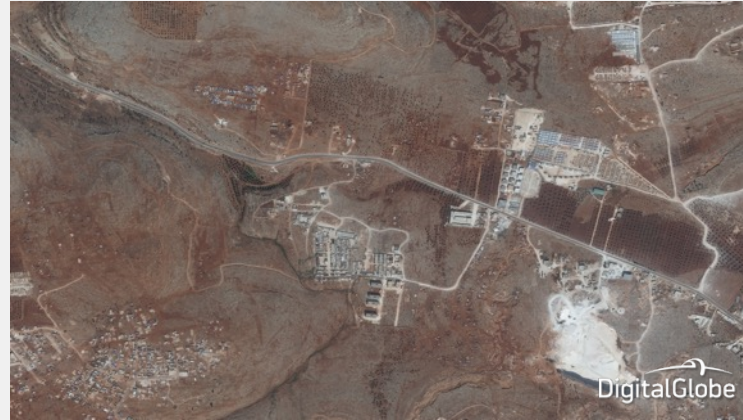
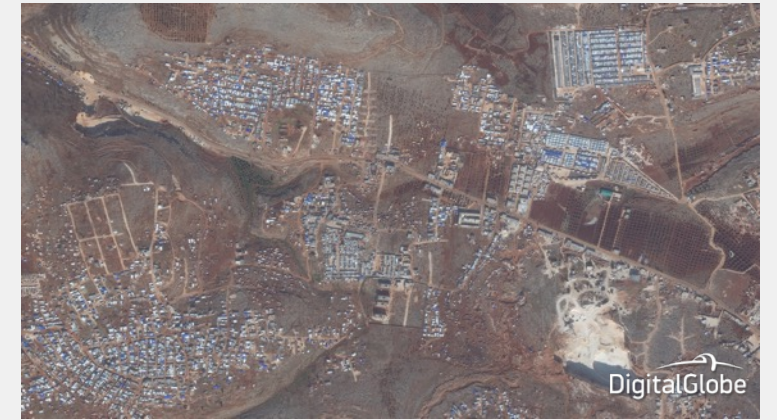
Fig 6.d. IDP camp formalization, expansion, and density increase, Idlib Governorate

Although growth is apparent between 2017 and 2018, by 2 December 2019 this site has expanded at a far more rapid pace consistent with reports of IDP influx.

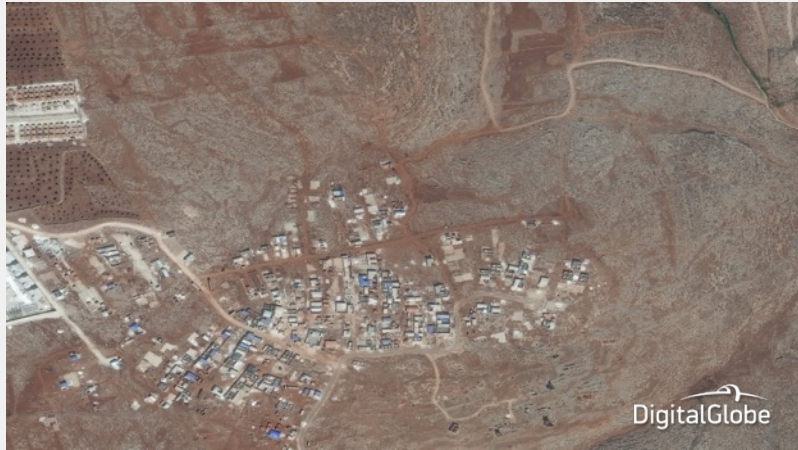
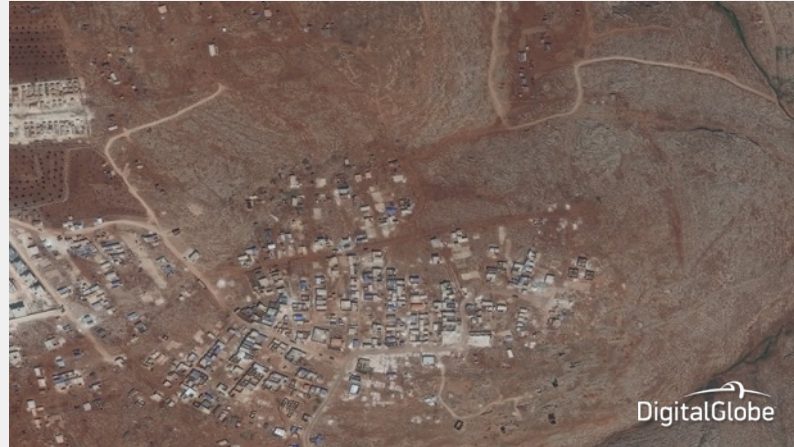
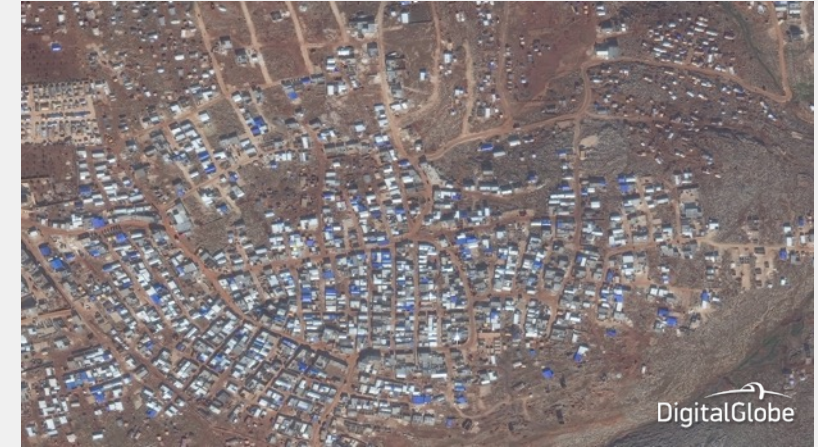
Fig 7.d. IDP expansion, formalization and density increase 2017-2019, Idlib Governorate

Meaningful but relatively modest growth between 2017 and 2018 is dwarfed by the increase in overall camp size, formalization and density by late 2019.
