Displacement & Destruction: Analysis of Idlib, Syria 2017–2020

4 March 2020

Areas of Interest

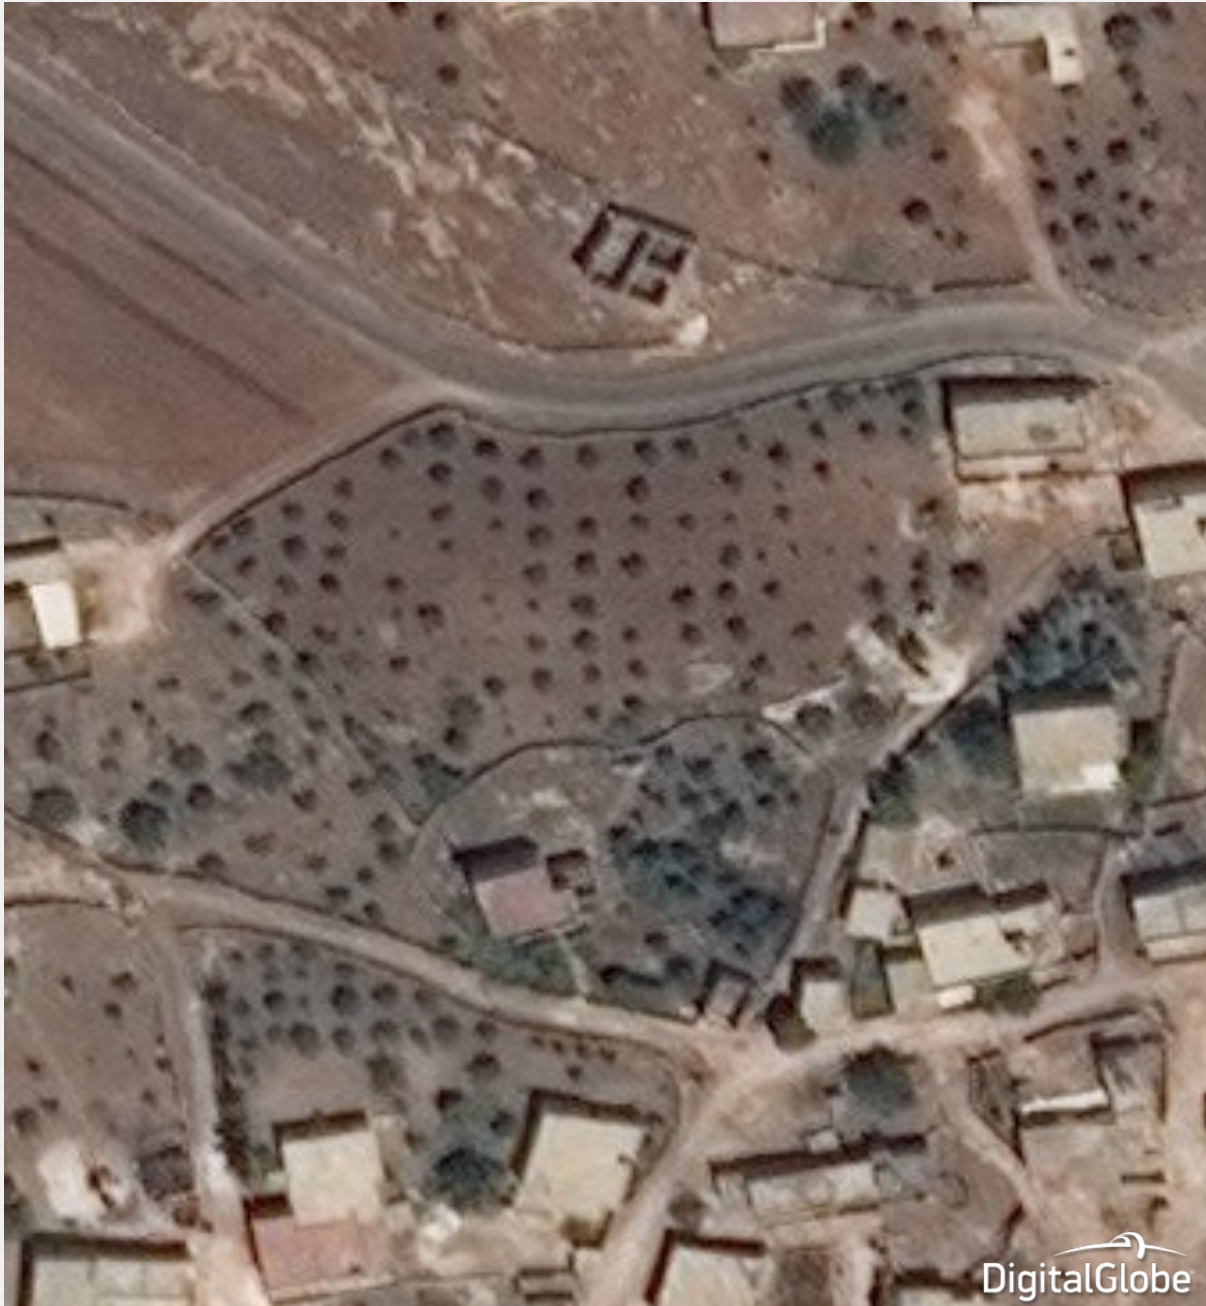
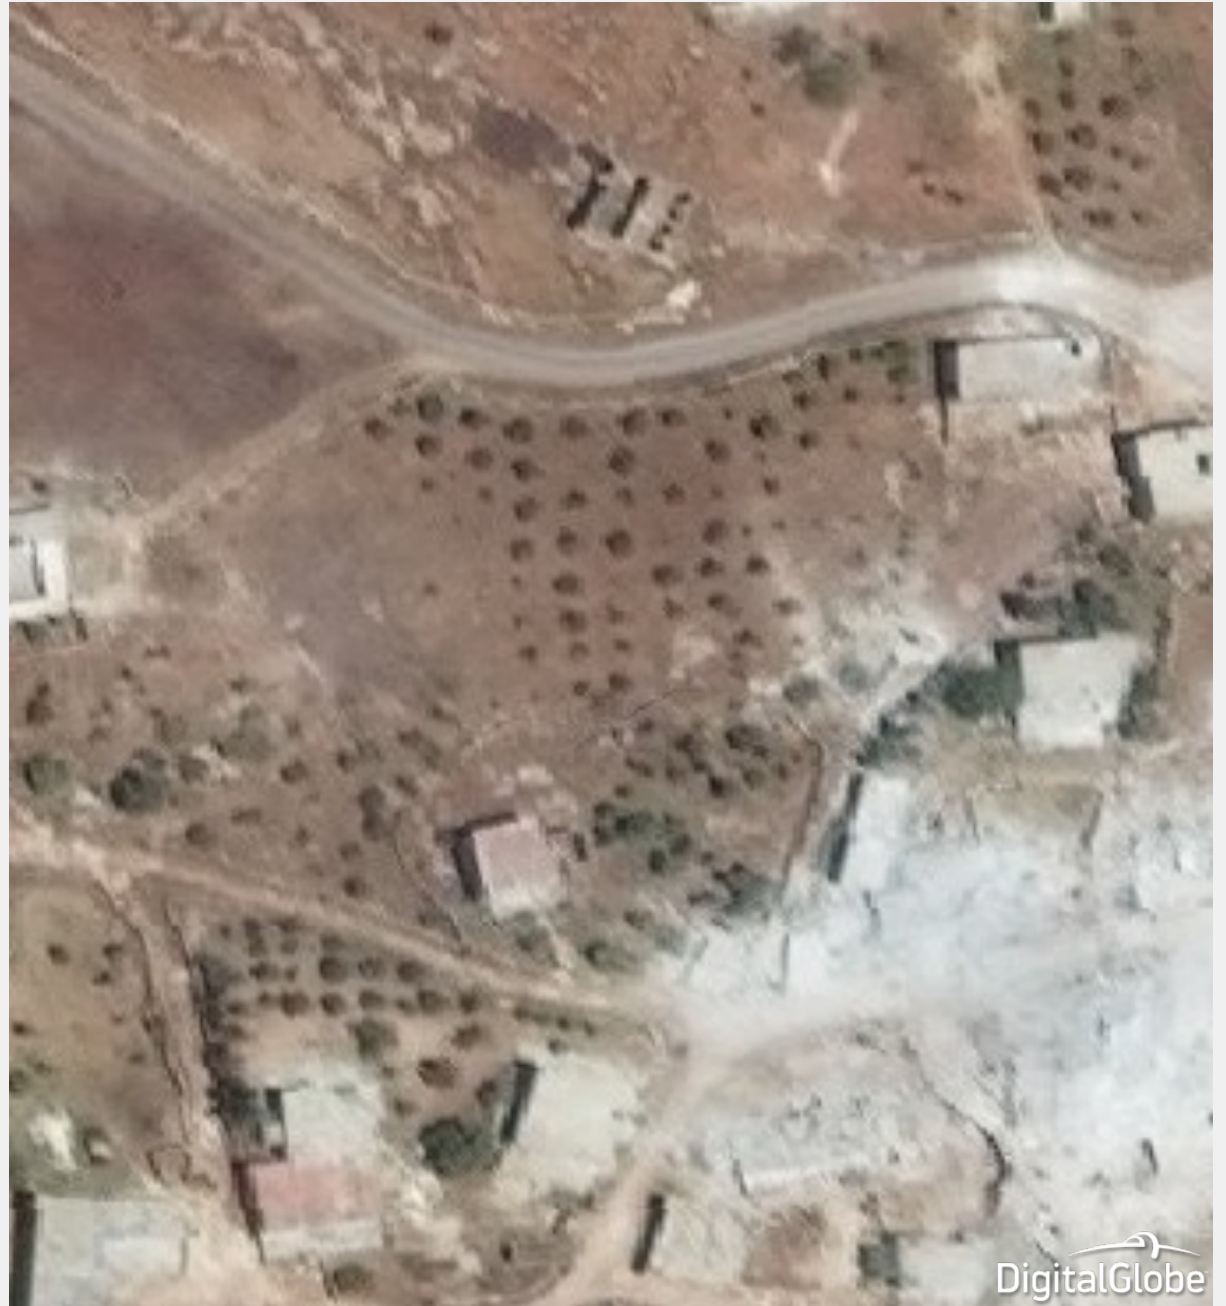
In imagery acquired 26 May 2019, cratering consistent with aerial bombardment appears at this site. Indications of scorched earth appear consistent with secondary fire caused by aerial bombardment, causing damage to surrounding crops.

Approximately 30% of the structures at Location C and D appear significantly damaged or obliterated, while the ground surrounding the structures remains largely intact. Ground reports suggest that the settlements in the analyzed region are no longer populated. While the satellite imagery indicates that a third of the settlements are destroyed, the imagery cannot verify the presence or absence of people. In the immediate surroundings of the structures in Locations C and D, there is visible evidence consistent with cratering as a result of mortar shelling and aerial bombardment. In May 2019, an active smoke plume as a result of fire is still visible at Location D. There appear to be track marks across the fields as well, though the timing of the tracks and craters may be unrelated.

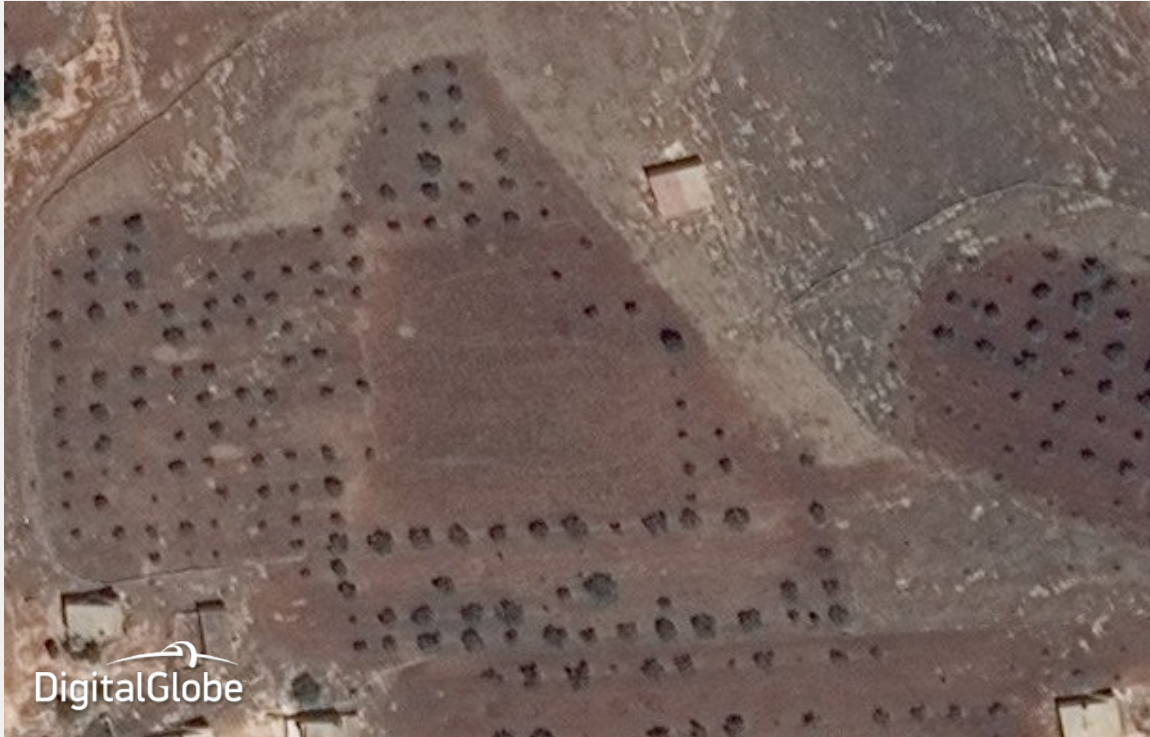
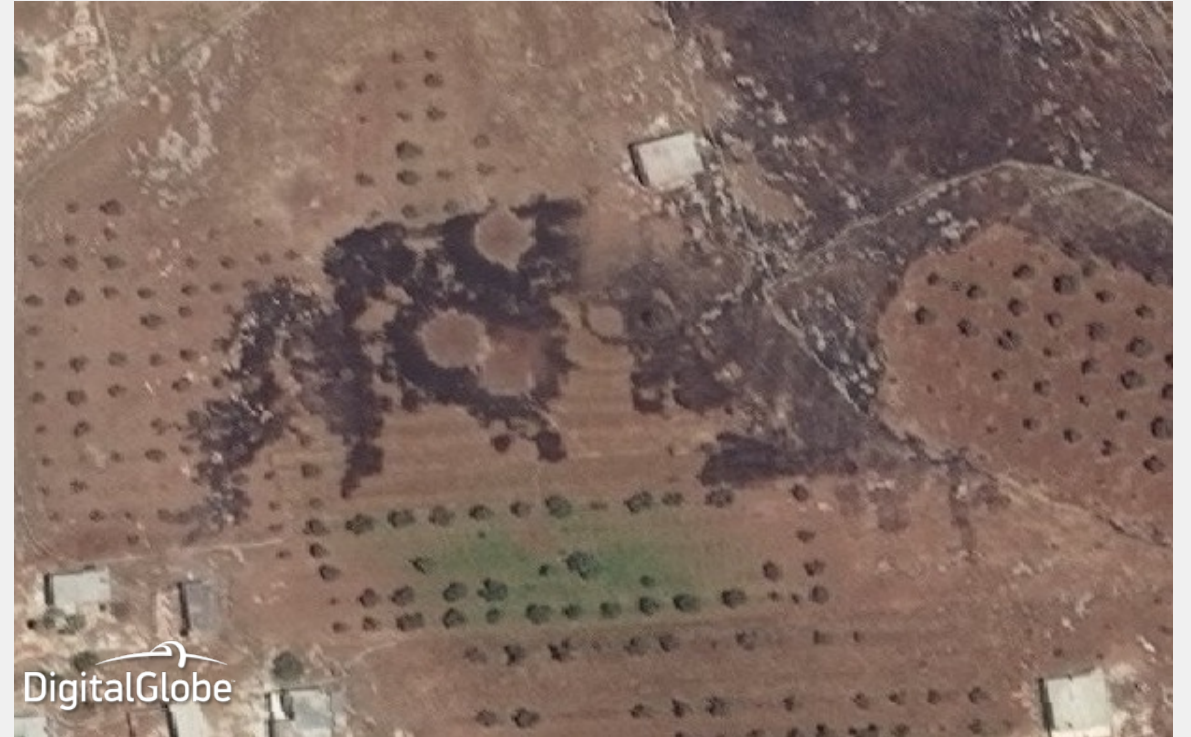
Fig 3.e. Cratering consistent with aerial bombardment, Idlib Governorate

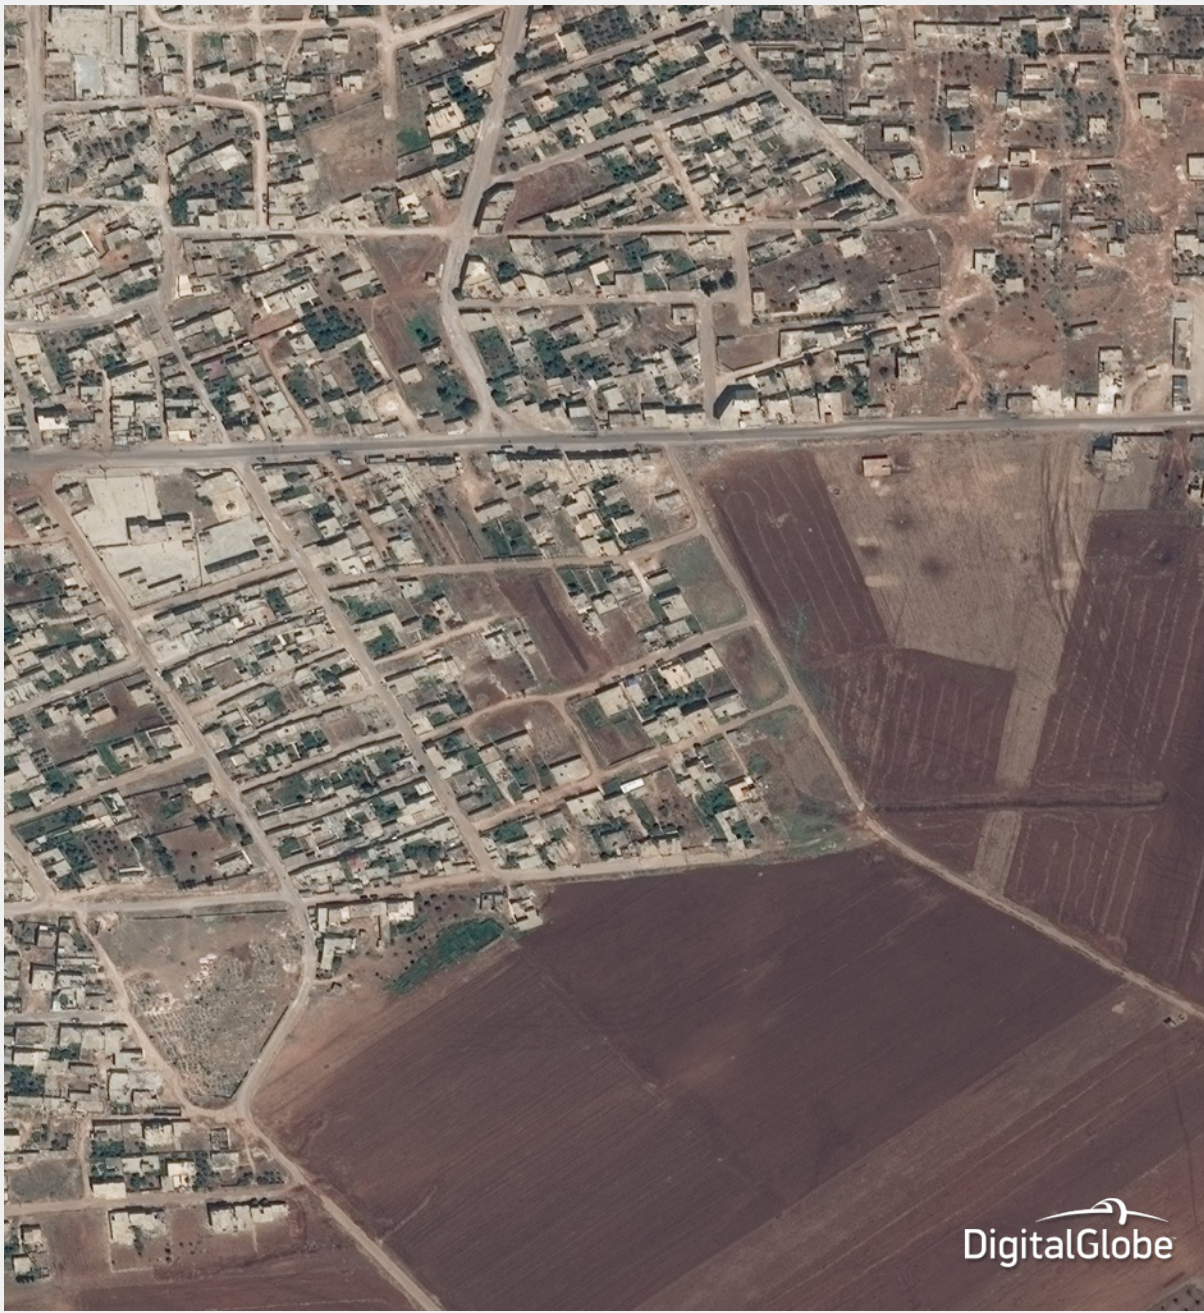
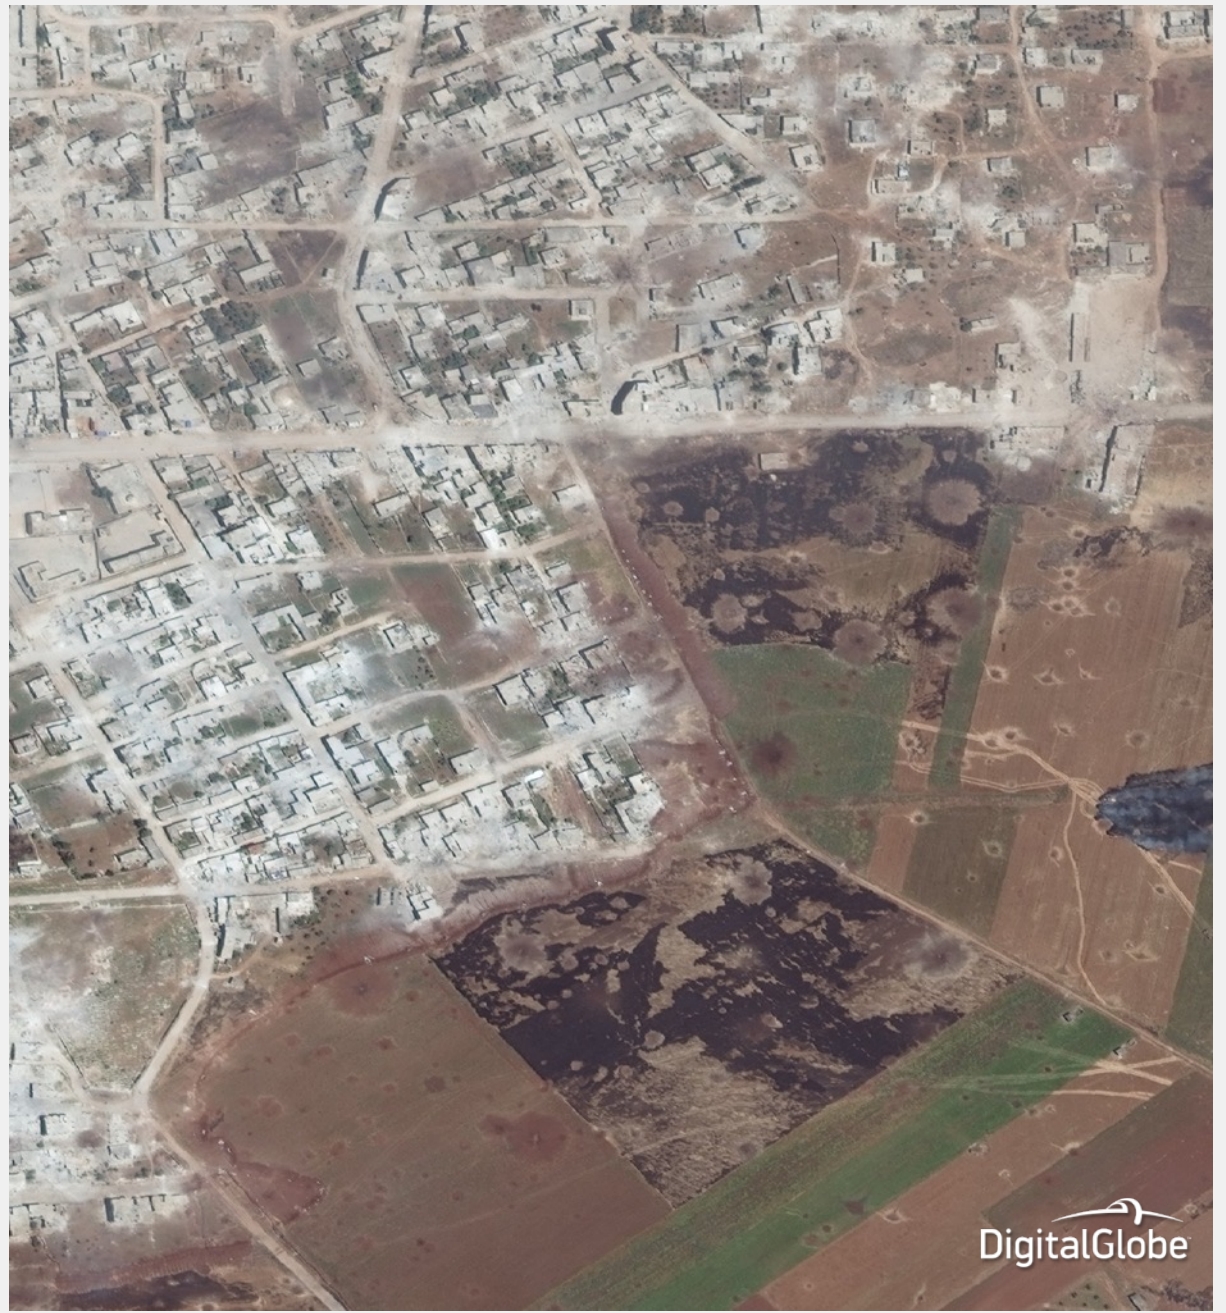
Fig 14.a. Apparent aerial bombardment, Idlib Governorate
Large craters consistent with aerial bombardment appear in the fields beyond the town; scorched earth due to secondary fires caused by bombardment is apparent, as a smoke plume rises from a still-burning plot of land. Smaller craters may be due to other, smaller forms of bombardment (e.g. mortars). Extensive damage to structures throughout the town is evident and consistent with aerial bombardment. It is important to note that not all structural damage may be evident via satellite imagery, as damage from shelling may render buildings unusable but still partially standing.
